Study of Failure Analysis of Gas Turbine Blade

Patil A.A.*, Shirsat U.M.

Department of Mechanical Engineering, SND COE & RC Yeola, Nashik, India

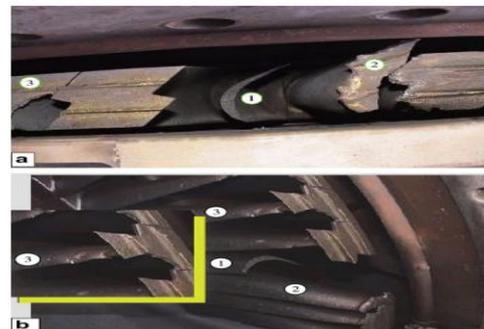
Fig. 2 .2a and b shows the failed blade in the second stage of turbine, which signed as number 1. As a result of failure the fragmented part has damaged the leading edges and shroud tips of some blades (Fig. 2.2b). Three blades were submitted to the laboratory. The tip regions of the blades 2 and 3 were severely damaged presumably by impact; however the tip damage was not the focus of this investigation. All three blades were corroded by the pitting mechanism. The region of pitting on the concave surface of the airfoil was near the leading edge, and on the convex surface was near the trailing edge (Figs. 2.3 a and b). The pits on the leading edge were more critical and in some cases appeared like the transverse notches (Fig. 2.4). It should be noted that the height of the fracture surface from the platform at leading edge in blade number 1 was the same as the position of critical pits in blade number 3 (Fig. 2.5). There was not a considerable deposit on the blades surfaces.

Fig.2.2. Position of the failed blade and the damages were caused due to failure.

(a) Upper view of the failed blade and surroundings.

(b) Leading edge damage in some blades.

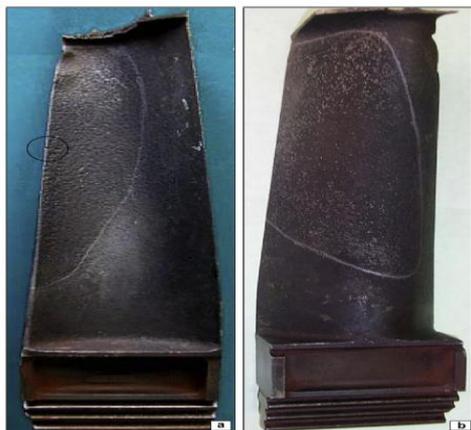
Fig. 2.3 General view of the blade number 3 showing corroded regions.
(a) Concave surface. (b) Convex surface.

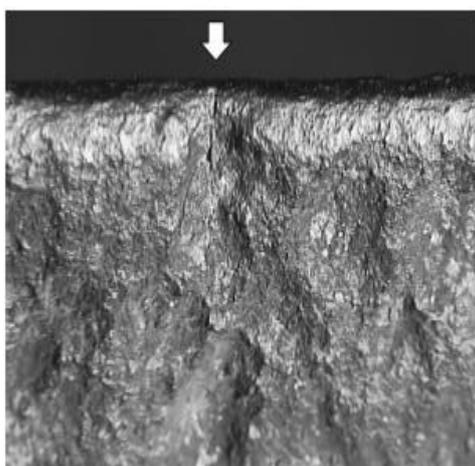
Fig. 2.4. The critical pit which is encircled in Fig. 2.3a. 20x.

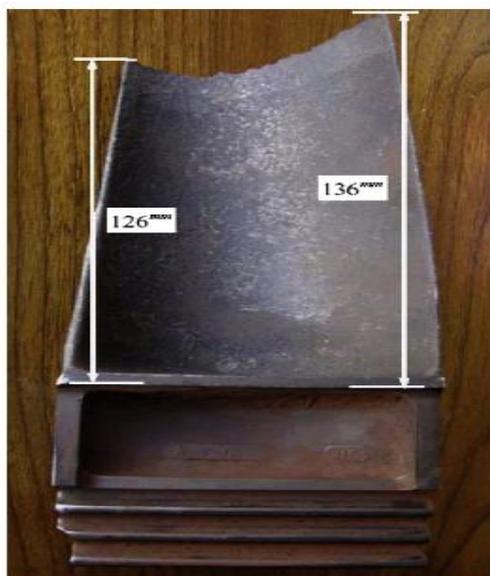
Fig. 2.5. The distance of the fracture surface from the platform at blade edges.

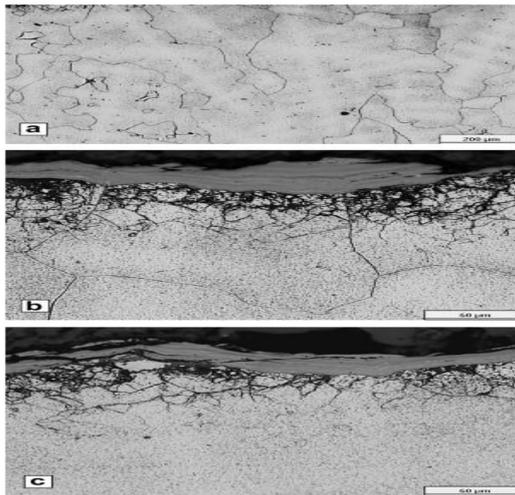
from the blade airfoil near the fracture surface and blade root. Fig.2.7 illustrates the micrographs of the material. As to be observed the microstructure has composed of dendritic grains (Fig. 2.7a), which is a characteristic of cast structures. There is a relatively compact scale on the surface of the blade. Although this scale was not continuously built up all over the surface, in some regions there is a noticeably thick scale (Figs.2.7b and c). Underneath the scale, a severe deterioration can be noticed. The severity of this deterioration was to a greater degree in the samples of leading edge, especially on the concave surface. This is in relation with the results of visual examination. Figs. 2.7a and b shows that there are a lot of micro cracks were initiated from the surface. Metallographic examination at higher magnifications carried out by means of scanning electron microscope (SEM). Microprobe analysis was carried out on the scale and subscale regions

Fig. 2.7. Optical micrograph of the blade material. (a) Dendrite microstructure. (b) Surface scale and subscale deterioration. (c) Same as from another place.

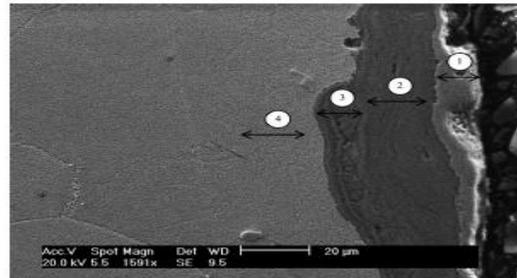
(Fig. 9) using an Energy Dispersive X-ray (EDX) analyzer attached to the SEM. The surface scale is comprised of three main components marked with number 1 to 3. In the external region (number 1), the scale composed of relatively unprotective nickel and cobalt oxides. The middle area (number 2) is primarily constituted of protective chromium and aluminum oxides. The internal layer (number 3) is comprised of chromium sulfide and chromium oxide which is the sign of hot corrosion. Furthermore, presence of sulfur at the subscale (number 4) was detected. Also it is observed that the nickel percentage was decreased and the cobalt percentage was increased at subscale which is signifying the depletion of nickel from subscale.

Fig.2.8. Regions of microprobe analysis.

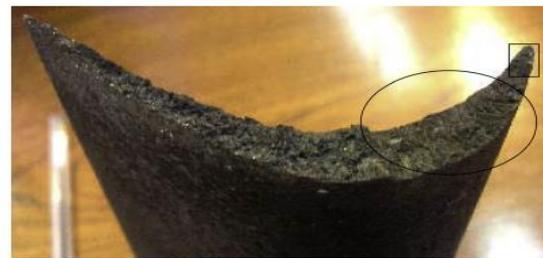
Fracture surface of the failed blade was examined by stereomicroscope and SEM. General View of the fracture surface is shown in Fig. 3.8. Two regions were clear on the surface. The first region which has marked with rectangular is the crack initiation area and the second region which has marked with an ellipse is the crack propagation by fatigue mechanism. Fig. 2.9 has taken from the area inside the rectangular of Fig. 2.8 at higher magnification. As observed in this figure the dendrite morphology is clear on the surface. This morphology demonstrates that the crack path has been interdendritic at initiation area. It can be considered as a sign of hot corrosion. Fig. 2.10 exhibits a high magnification fractograph from the region inside the ellipse in Fig. 2.11 In this area fatigue marks (striations) are evident. It indicates that after the initiation of the crack, propagation has conducted by the fatigue mechanism due to the vibration of the blade. Fig. 2.11 illustrates two fractographs of different magnifications from

Fig. 2.9 General view of the fracture surface.

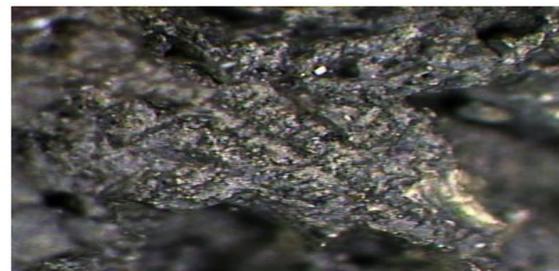
Fig. 2.10 Dendrite morphology in the vicinity of the rectangular in Fig. 2.9. 20x.

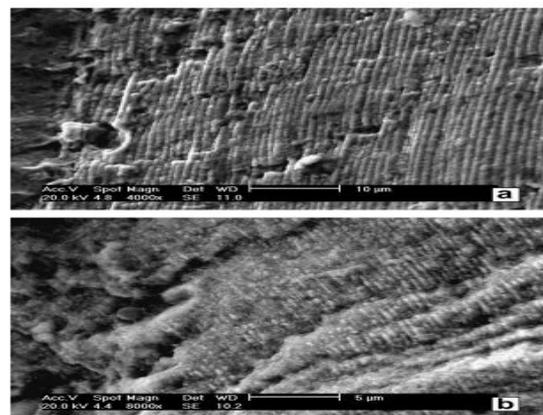
disconnected regions in the vicinity of fatigue crack propagation. It demonstrates that the crack growth was occurred with different stress levels and frequencies. After crack growth and subsequent reduction in cross-section area, final fracture has occurred in the trailing edge of the blade.

Fig. 2.11. Fatigue striations in the vicinity of the ellipse in Fig. 2.9 from different regions. (a) 4000x. (b) 8000x
