## The Architectural Investigation of Akseki Butonned Houses and Suggestions for Their Restoration

Ahmet GÖKDEMİR<sup>1</sup> Onur ÖZEN<sup>2</sup>

Ahmet GÖKDEMİR. " The Architectural Investigation of Akseki Butonned Houses and Suggestions for Their Restoration." IOSR Journal of Engineering (IOSRJEN), vol. 08, no. 11, 2018, pp. 23-31.

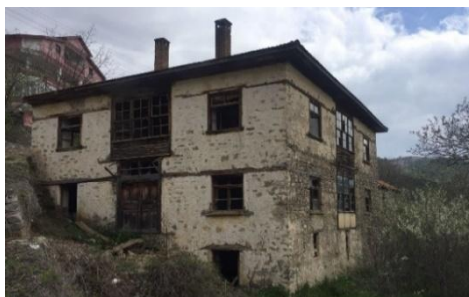
**Figure 11: The Mentioned House [13]**

In this study, we investigated a 3-storey house which is in Akseki, Bademli district, block of 191 and parcel of 6 (see Figure 11). This house which is built according to the butoned house technique, consists of six rooms, two kitchens, two kiosks, two stables and one straw. The house is single-storey from the road front and has three-storey from the rear front due to the difference in the elevation. The floor plans of the house are shown in Figure 12.

**Exterior Front:** Stones and plasters on the exterior front must be repaired with appropriate material. Labourer must be careful about original construction. (see Figure 11)

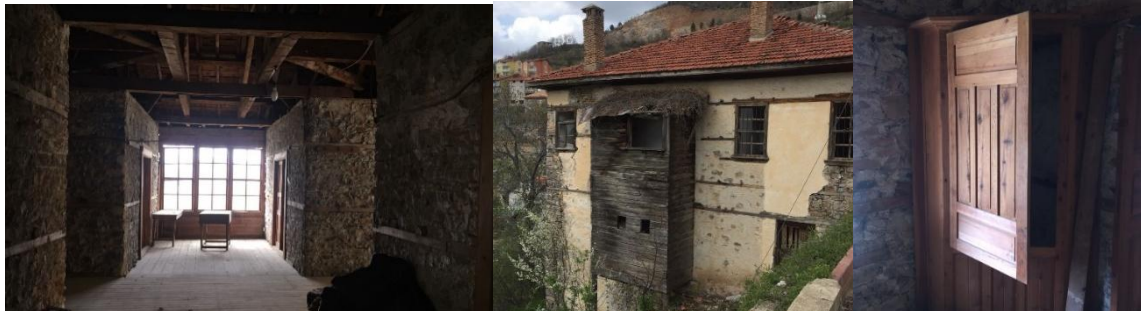
**Figure 13: Walls and Floor [13]** **Figure 14 : Cumba,Windows and Cupboard [13]**

**Floor:** The building floors are in the form of wooden rafters and underlay cladding boards. They are in good condition and cleaning is sufficient without any damage. (see Figure 13)

**Internal walls:** The internal walls are generally in good condition, but some rooms have plaster spills. Room interior plasters should be removed and plastered in accordance with the original. This feature of unplastered walls in pavilions and corridors must be protected. (see Figure 13)

**Cumba and Pavilion:** The cumba and pavilions on the two sides of the building should be removed because they are seriously damaged. It must be re-manufactured according to the same wood material and assembly should be performed. (see Figure 14)

**Windows:** The windows are generally damaged. It must be disassembled and re-manufactured according to the original of the same material and assembly should be performed. (see Figure 14)

**Cupboards:** Since the cupboards which are made of wood, are in good condition, they must be protected by cleaning without damaging them. (see Figure 14)

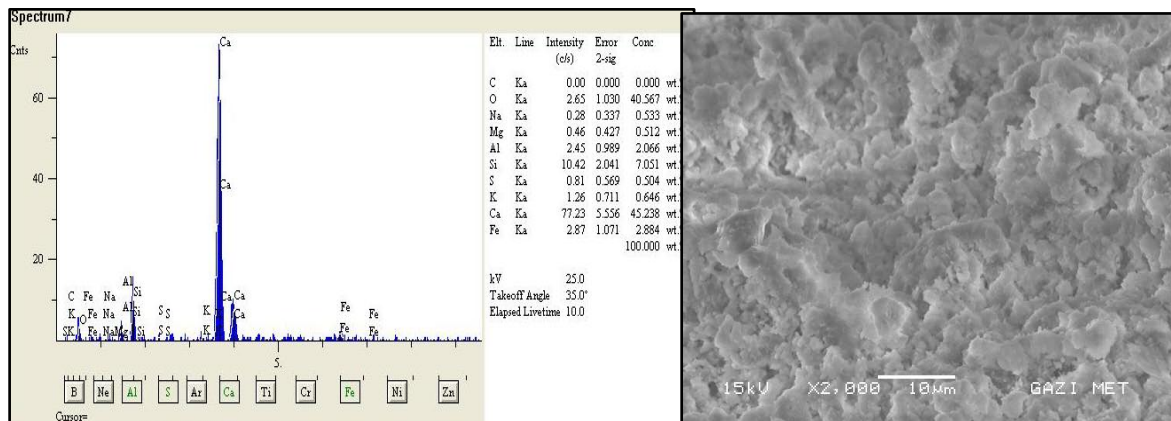
**Analysis Result I: The EDS and SEM Analysis Results of West External Cast Mortar**

In the SEM analysis of west external cast mortar, in x2000 magnification, the particles exhibit a homogeneous structure in oval shapes in dark gray and gray colors. Calcium (Ca), Silicium (Si), Aluminum (Al), Oxygen (O), Iron (Fe) and Potassium (K) elements are mainly found in the EDS analysis.

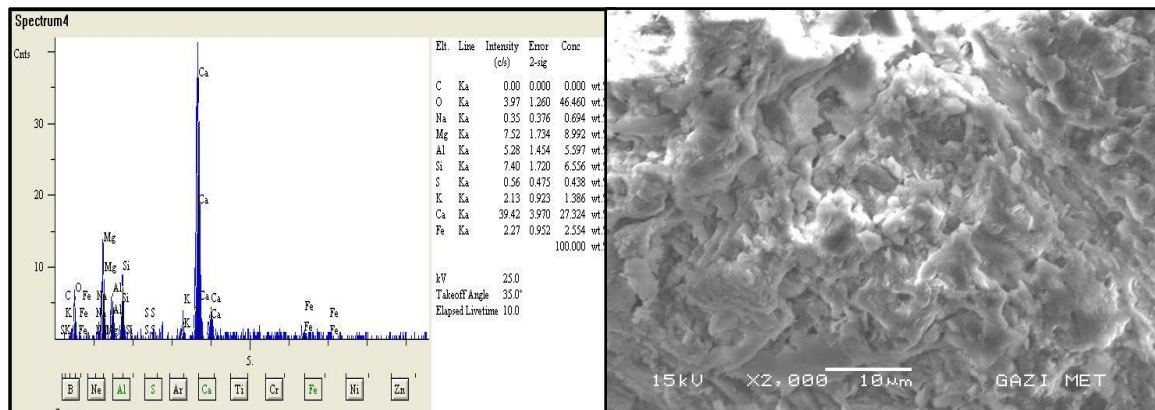
**Analysis Result II: The EDS and SEM Analysis Results of West External Stone**

In the SEM analysis of west external stone, in x2000 magnification, the particles shows oval, more grift and an intertwined structure. Calcium (Ca), Magnesium (Mg), Silicium (Si), Aluminum (Al), Oxygen (O), Iron (Fe) and Potassium (K) elements are mainly found in the EDS analysis.

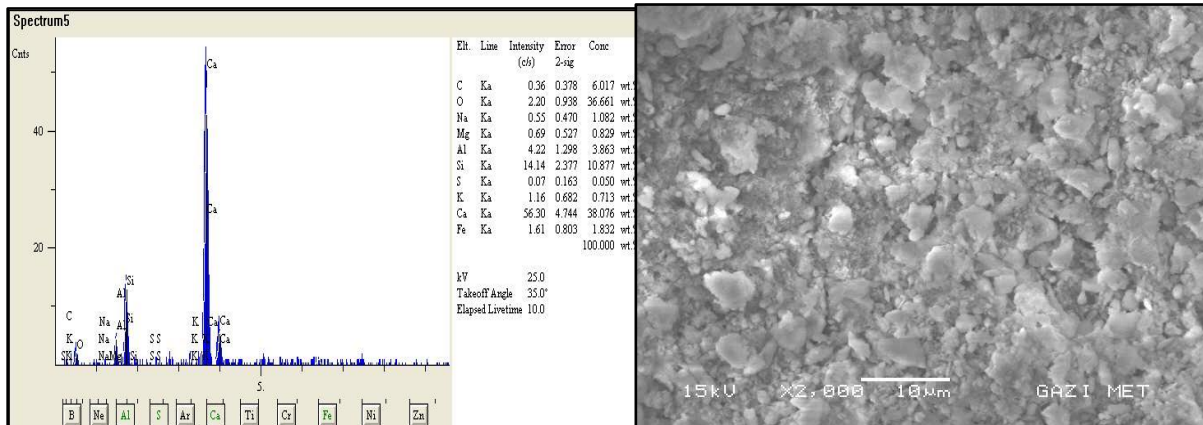
**Analysis Result III: The EDS and SEM Analysis Results of East External Cast Mortar**

In the SEM analysis of east external cast mortar, in x2000 magnification, the particles which are dense in partial areas and rarely seen in some areas, have polygonal shape. Calcium (Ca), Silicium (Si), Aluminum (Al), Oxygen (O), Iron (Fe) and Potassium (K) elements are mainly found in the EDS analysis.

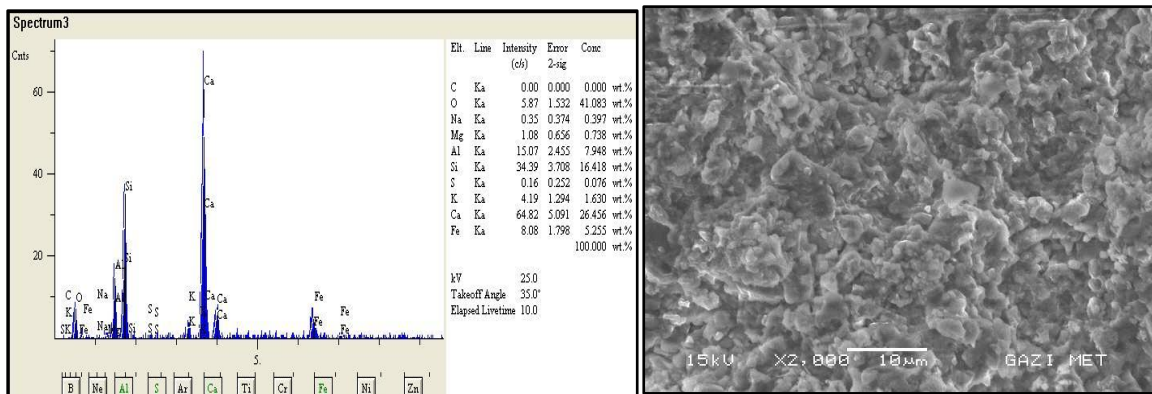
**Analysis Result IV: The EDS and SEM Analysis Results of East External Stone**

In the SEM analysis of east external stone, in x2000 magnification, the particles exhibit a homogenous structure with grift and densely oval motifs. Calcium (Ca), Silicium (Si), Aluminum (Al), Iron (Fe), Oxygen (O), Potassium (K) and Magnesium (Mg) elements are mainly found in the EDS analysis.

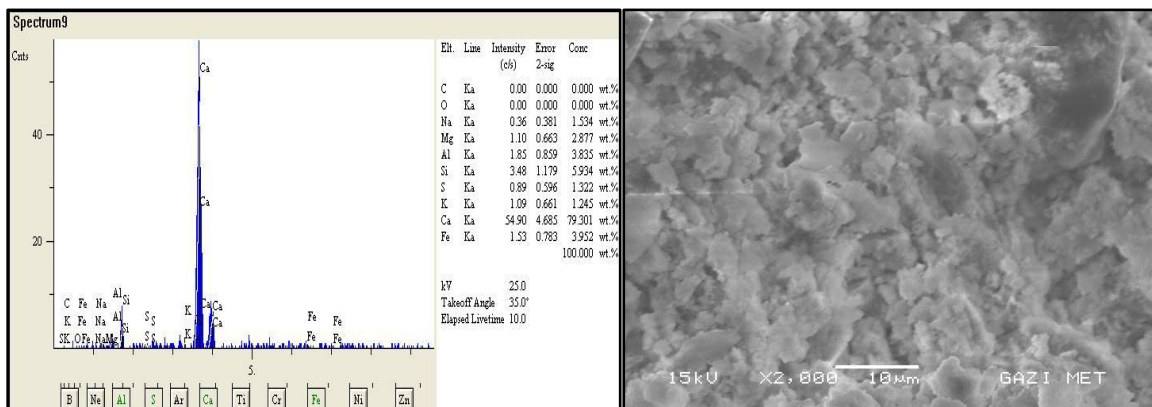
**Analysis Result V: The EDS and SEM Analysis Results of South External Cast Mortar**

In the SEM analysis of south external cast mortar, in x2000 magnification, the particles form a partially homogenous structure with oval geometric shapes. Calcium (Ca), Silicium (Si), Aluminum (Al), Iron (Fe), Magnesium (Mg) and Potassium (K) are mainly found in the EDS analysis.

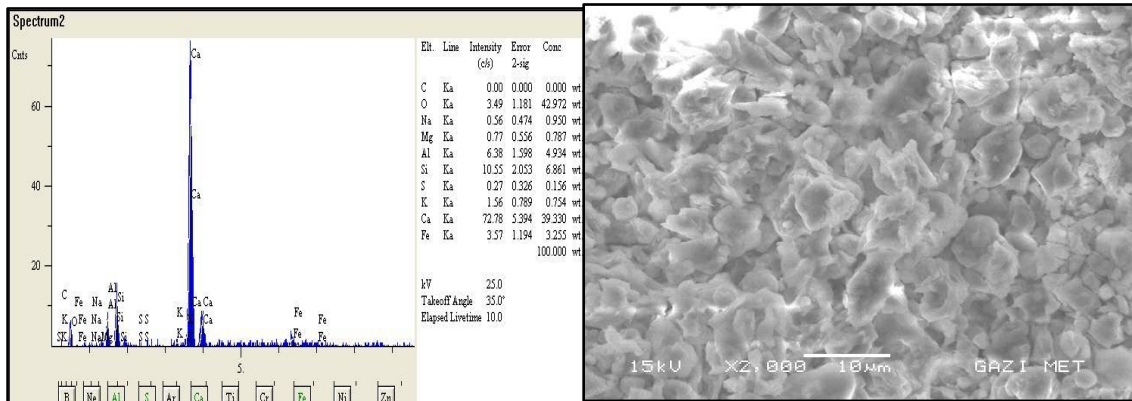
**Analysis Result VI: The EDS and SEM Analysis Results of South External Stone**

In the SEM analysis of south external stone, in x2000 magnification, the particles formed an amorphous structure by taking oval shapes in their diameters and holding them together. Calcium (Ca), Silicon (Si), Aluminum (Al), Iron (Fe), Oxygen (O), and Potassium (K) elements are mainly found in the EDS analysis.

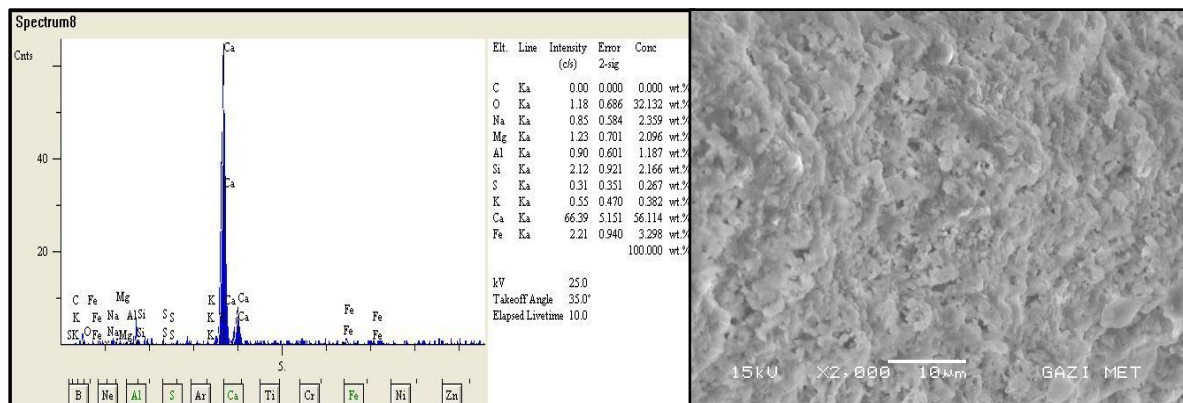
**Analysis Result VII: The EDS and SEM Analysis Results of North External Cast Mortar**

In the SEM analysis of north external cast mortar, in x2000 magnification, the particles are maintained their homogeneous position by bonded to each other in non-geometric forms. Calcium (Ca), Iron (Fe), Silicon (Si), Magnesium (Mg) and Oxygen (O) elements are mainly found in the EDS analysis.

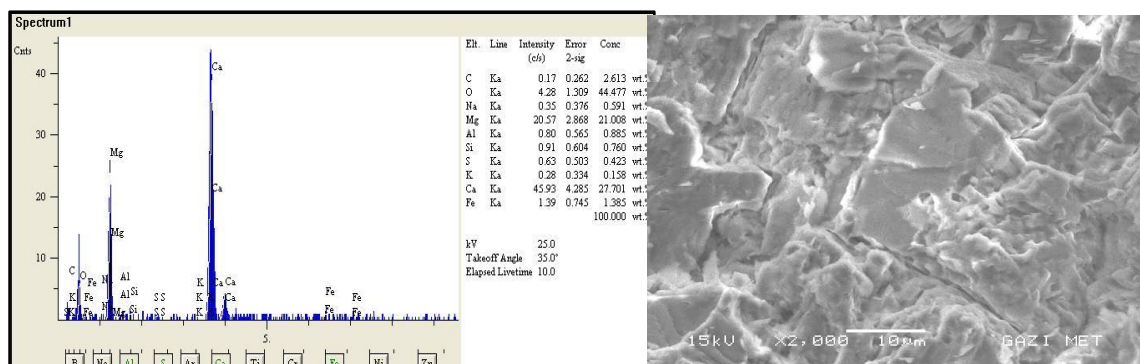
**Analysis Result VIII: The EDS and SEM Analysis Results of North External Stone**

In the SEM analysis of north external stone, in x2000 magnification, it was observed that the particles were interlocked with uneven sharp geometric shapes. Calcium (Ca), Magnesium (Mg), Oxygen (O) and Iron (Fe) elements are mainly found in the EDS analysis.
