The Structural Damages After Nepal Earthquakes

İbrahim Baran KARAŞİN¹, Dursun BAKIR², Mustafa ÜLKER³, Ali Emre ULU⁴

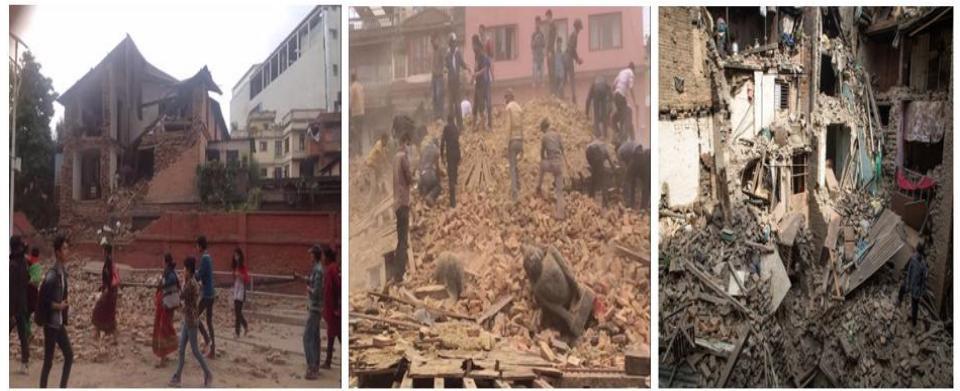
In villages, the dominant building type consists of adobe and stone masonry buildings minimally reinforced with timber lintel beams. The masonry structures were built with regional adobe stone and wooden roof. These buildings that were built with soil mortar have partially or completely during the earthquakes (Fig. 2). Due to atmospheric conditions at time, degradation both in material and in connections can be observed. Connection between walls and roof were not observed in most structures. These buildings were constructed by

their own residents without any engineering knowledge. The reason of the vast majority of the collapse of the gable walls is their inadequate connection to the structure and their construction with missing lintels.

Figure 2. Damages of masonry structures

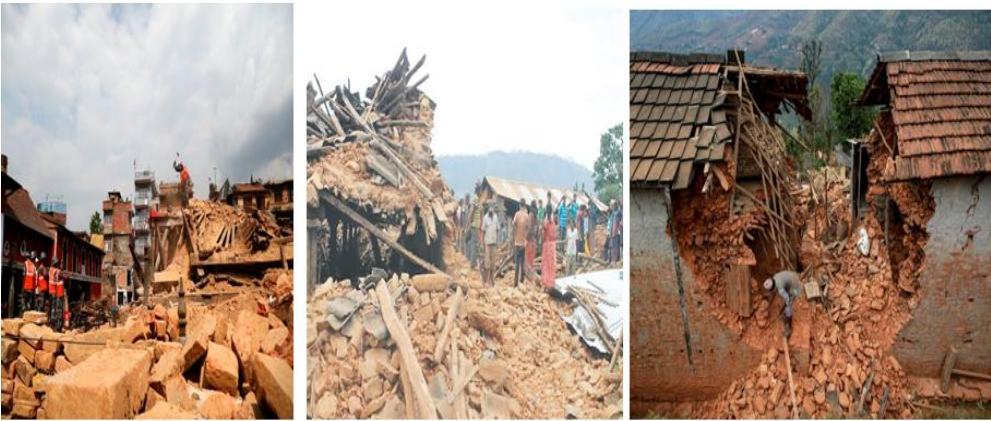
Nepal is in Katmandu Valley and this Valley in particular is very susceptible to earthquake [20]. The mud material is used as mortar in between bricks in all structures generally. Mud has very weak strength compared to the strength of brick and timber. In case of greater thrust the mud mortar cracks and helps to displace wall thus absorbing the thrust. This causes partial collapse preventing total collapse of the building. The vernacular house is made of clay, brick, timber and stone, which are very weak. Most of the old mud-mortar and stone buildings of the Kathmandu Valley are similar to those of Turkey's rural areas. The damage in Nepal was similar to damage in Turkey after earthquakes. Another widely used material in masonry structure is regional stone. The binder used in such structures is low-strength cement mortar or clay. Poor quality of this binder is one of the reasons for the structural damages in rural regions (Fig. 3).

Figure 3. Damages to the poor quality of mortar in stone structures

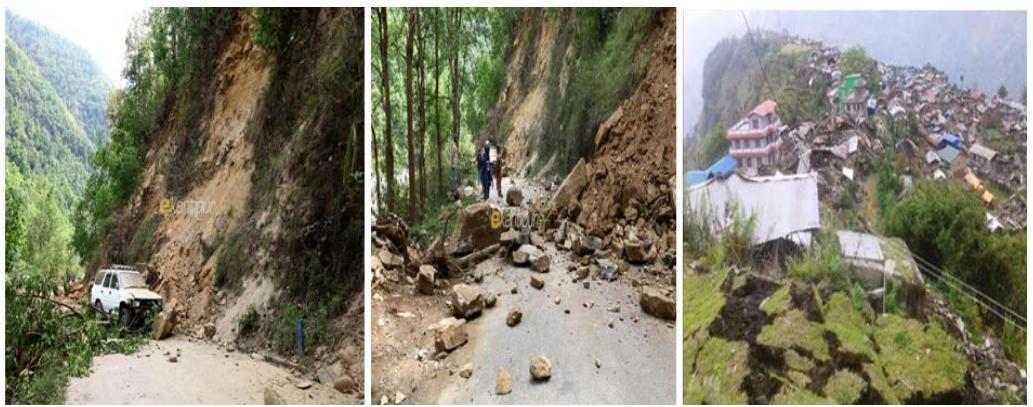
Earthquakes caused secondary hazards such as landslides and rockfalls. A landslide, also known as a landslip, is a geological phenomenon that includes a wide range of ground movements. Rockfall is a kind of geotechnical damage that could be observed after earthquake. Rockfalls, deep failure of slopes and shallow debris flows were common. Landslides cause damage to transportation routes, utilities, and buildings and create travel delays and other side effects. Rockfall incidents occurred in Nepal highway and nearby slopes (Fig. 4). In order to decrease the impact of landslide and rock falls on urban and rural areas first of all it is essential to take geological hazard possibilities in to consideration and prevent construction on the terrain which carry risk and also minimize the existing risks as well. As a result, detailed mapping of the regions which are under risk of landslide and rock fall should be made as soon as possible.

Figure 4. Rockfalls and landslides

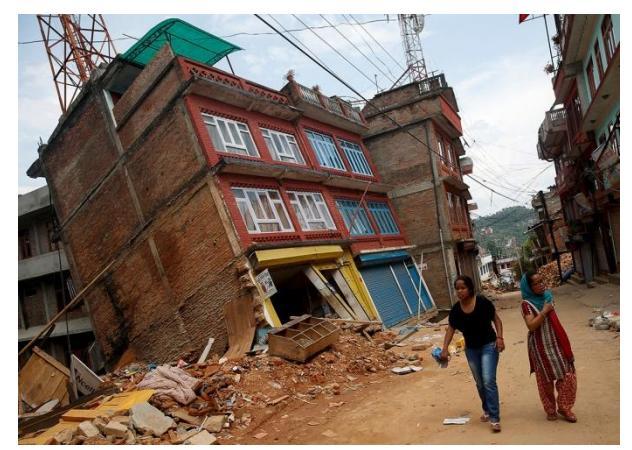
The other damage type is foundation damage. In projecting of structure systems, it is necessary to take the interaction between structure-foundation-ground triplet into consideration and take the effects of deformations caused on ground layers due to loads transmitted to the ground on inner forces and load distribution in foundation element and superstructure load bearing system into account. While designing engineering structures structure foundation should operate in accordance with the ground as much as possible and should fulfil the design criteria in geotechnical and structural means. Ground-structure interaction is generally reduced only to resolution of foundation element. Structure-ground interaction should be a nonnegligible element of structure design. There is no damage in structural system but the building was separated from the ground. Adherence between the ground and the building is not enough (Fig.5). In a frame of a common model where ground environment, foundation type and superstructure are taken into consideration together, mutual interaction of ground and structure during earthquake should be taken into account while making the calculations.

Figure 5. Foundation damage (Source: http://www.ibtimes.co.uk/nepal-buildings-lean-precariously-aftermath-second-earthquake-photo-report-1501297)

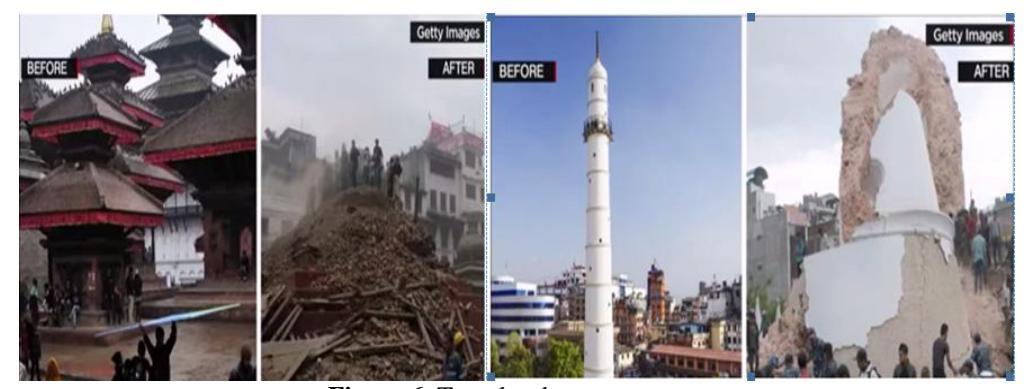
and masonry having low tensile strengths is likely to be destroyed. [21]. The temples were mostly unreinforced (Fig.6).

Figure 6. Temples damages (Source: http://www.ibtimes.co.uk/nepal-buildings-lean-precariously-aftermath-second-earthquake-photoreport-1501297)

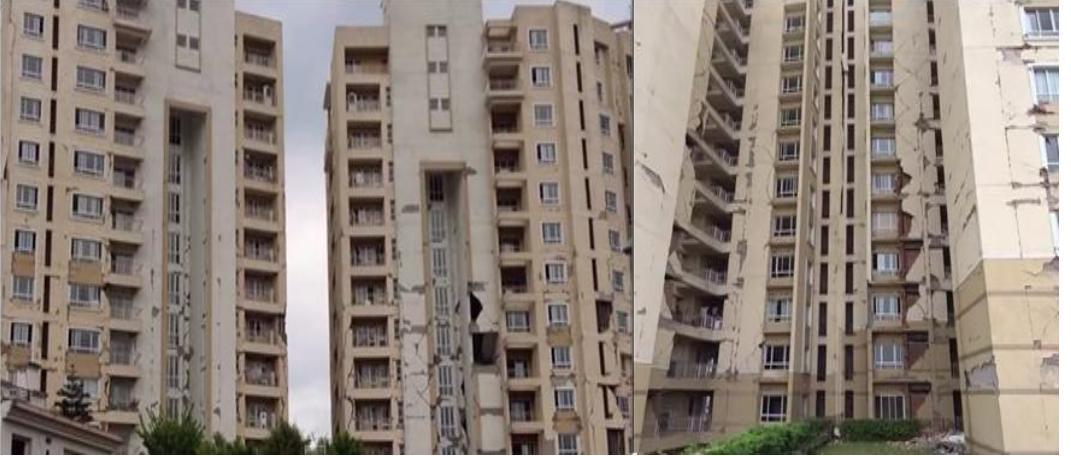
X- shaped crack is a kind of earthquake damage in the structural walls in RC buildings. These cracks have continued to the inner of these structural walls [22]. The walls within concrete frame are generally protected by the frame. at the same time, they limit the movement of the frame and carry horizontal load. The damage which initially starts by infill wall and frame later advanced as X shaped shear cracks on high earthquake horizontal load levels. The level of the damage also depends on the story displacement rate of the structure during earthquake. This typical damage due to earthquake has also been observed in Nepal (Fig. 7). Building the walls that completely fills the frame gaps by highly resistant wall material and mortar will increase the horizontal load bearing capacity of structures.

Figure 7. Walls damage

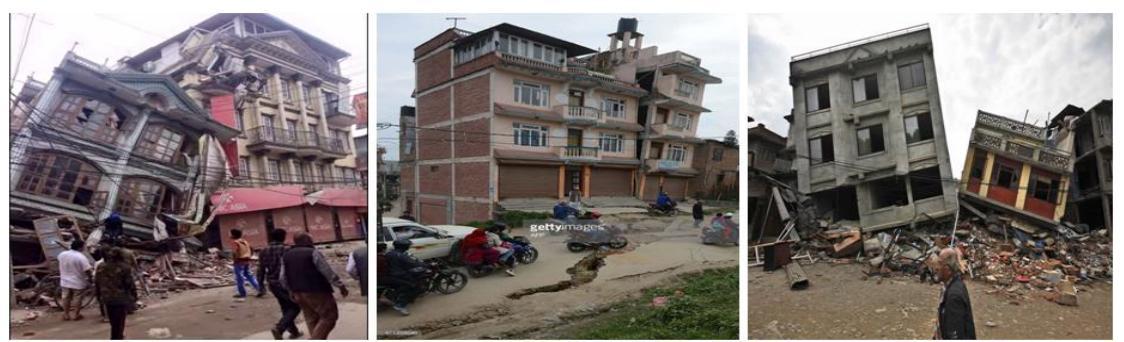
The problem of pounding is unavoidable in many large cities located in seismically active regions where, due to land usage requirements, buildings are constructed adjacent to each other. The buildings which are adjacent to each other carry a high risk because of different periods because of their different heights and weights of buildings due to the principle of conservation of energy as seen as in past earthquakes [23]. Pounding effects that occur due to earthquake forces originated by lack of dilatation gap in contiguous buildings causes this kind of buildings to take heavy damage or completely collapse under that impact. Pounding damage of adjacent buildings in Nepal is given in Fig.8. Pounding effect should be decreased in contiguous buildings by leaving proper dilatation gap.

Figure 8. Pounding damages (Source: http://www.haaretz.com/israel-news/1.654075)

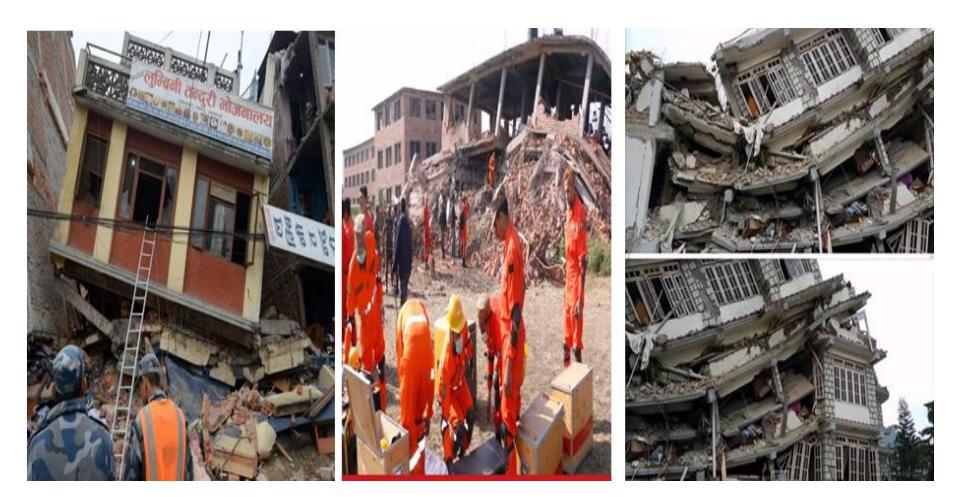
Infill walls are used generally in ground floors of buildings in order to create as wide areas as possible while infill walls are intensively used in upper floors so resistance differences occur between floors. As a matter of fact although building is string by all means, these structures take heavy damage/collapse because of weak/soft storey and building collapses observed in earthquake region (Fig.9). Weak/soft storey formation should be avoided, earthquake forces should be carried by partitions and frequent stirrups should be used in each section of columns of the floors demonstrating such negative property.

Figure 9. Weak and soft story damages (Source: http://www.haaretz.com/israel-news/1.654075)

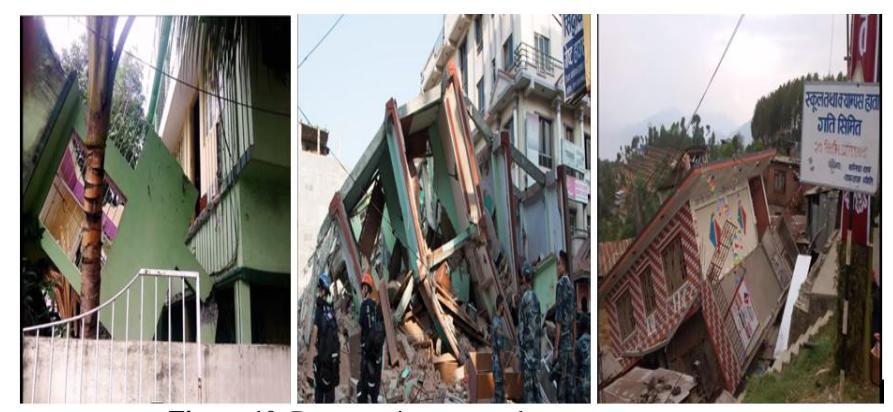
Frame damages are observed in columns more than the other elements of frame system in RC buildings because of columns were built weaker than beams. The reasons of much damage in columns are insufficient shear force bearing capacity of columns and inadequate adherence between concrete and reinforcement [22]. Damaged columns showed that reinforcements that were used in structural systems elements are not provided principles of regulatory of reinforcement that are given in National Codes. Especially wide spacing of the crossties related to buckling of longitudinal reinforcement. The concrete that was in the core region was diffused because of this buckling. In connection parts and column winding sections if there are not sufficient winding reinforcements, core concrete is easily smashed and longitudinal column reinforcements twist. Therefore, the column cannot bear the expected loads. Preventing the inner force distribution between elements cause decreasing in bearing element rigidity. The damages occurring in column-beam connection section are generally originated from unnecessary lateral reinforcement densification or insufficient connection of beam longitudinal reinforcements to the column. As the damage observed in connection section decreases the bearing system rigidity significantly the resistance of the system to the horizontal loads may suddenly decrease. Frame damages that observed in Nepal are given in Fig. 10. There should be no lack of connection in frame systems. Stirrup densification should be performed to column-beam cross-sections which are close to column-beam connection sections that are expected to be the most forced sections during earthquake.

Figure 10. Damages in structural system (Source: http://darkroom.baltimoresun.com/2015/05/second-earthquake-hits-nepal/#1)
