## The Proposal of Investigation and Restoration of Historical Kastamonu Castle's Architecture

Ahmet Gökdemir<sup>1</sup>, Can Demirel<sup>2</sup>

<sup>1</sup>Gazi University, Faculty of Technology, Civil Engineer, <sup>2</sup>Kırklareli University, Pınarhisar Vocational School, Construction Department, Turkey.

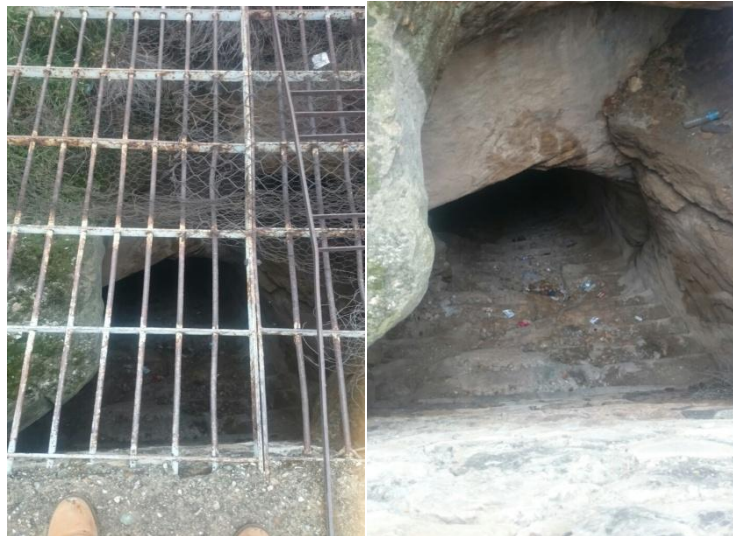
Picture 5. Tunnel, secret connected road with city [Author Archive]

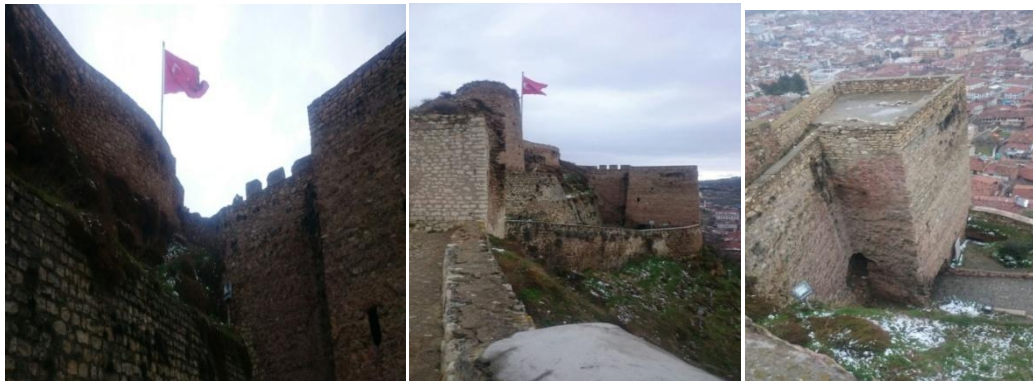
Picture 6. Inner Castle [Author Archive]

There is intensive vegetation on castle walls and on the floor of the castle. Plants which are near the wall and environment should be cleaned not to damage the castle walls. During repairing all sutures protective prevention to plant creation should be done by spraying in necessary places. For cleaning these types of plant roots, agricultural drugs (wild plant killer) which don't damage the surfaces of original stones can be used. Monsanto mark Roundup Ultra and Roundup Super can be suggested as herbicides that is necessary for this aim. It should be adulterated for 20%-25 in water and applied to fresh leaves of grass and ivy by spraying which is sold as liquid.
