Road Safety Audit of Rural Ghat Road at Vikarabad District

Abstract: A Road Safety Audit (RSA) is the formal safety procedure of an existing Road by an independent, multidisciplinary team. This paper explores the hazards of the roads and the confusing factors of the drivers. The road-selected area is from Vikarabad to Kerelli Towns. The road length is of 10 Kilometres. The road connects Vikarabad – Tandur towns of Telangana State. It is a busy road connecting the industrial, commercial areas, has a mixed traffic and Hilly terrain, which leads to accidents. The Audit had conducted following the guidelines of, IRC: 67-2012, IRC: 35-1997, IRC: SP: 88. Correction of Road signs, markings, message signs, hazard markers, traffic safety barriers, identification of Blackspots, delineators had done based on the requirements. This paper worked for Safe roads, Forgiving roads. In conclusion, we argue that significant measures need to take on Road Safety aspects to mitigate the accidents and ensure the safety to vehicular traffic.

N. Naveen. “Road Safety Audit of Rural Ghat Road at Vikarabad District.” IOSR Journal of Engineering (IOSRJEN), vol. 09, no. 02, 2019, pp. 21-26.

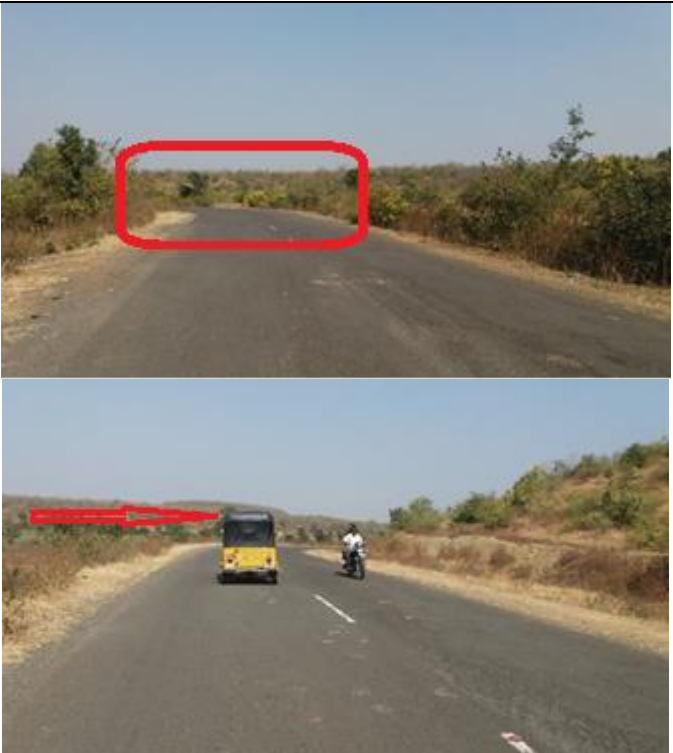
<p>22 – 48% of potential crash reduction can do by implementing the above things. Priority: Very Essential</p> <p>Observation: Insufficient site distance at the curve. Highway without markings and turning sign Boards. Nice shoulder width. Reason for Concern: Sudden turning will cause havoc in drivers mind and lead to a crash or runoff of the road. Recommendation: Warning and speed limit signs need to place. Rumble strips have to provide to alert the driver. Red – Yellow chevrons signs need to place at the turnings. Guard Rails need to install at the outer edge of the road. 15 – 60% potential crash reduction can be done. Priority: Very Essential</p>

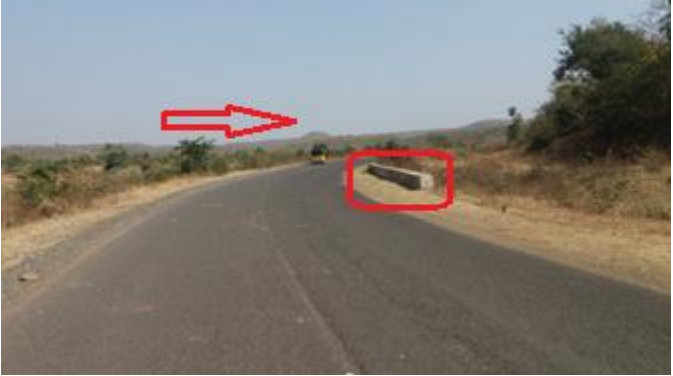
<p>Observation: No Guard Rail/side barriers at the curve of the road. No indication of the Culvert. Reason for Concern: Drivers may lose control of the vehicles at Turnings due to centrifugal force and may runoff of the road. Recommendation: Warning and speed limit signs need to place before the Culvert to give a caution. Markings and Rumble strips need to be provided to guide along the curve and alert the driver. Red – Yellow chevrons signs need to place at the turnings. Retroreflective stickers or paint has to do on the culvert walls facing the traffic. Priority: Essential</p>

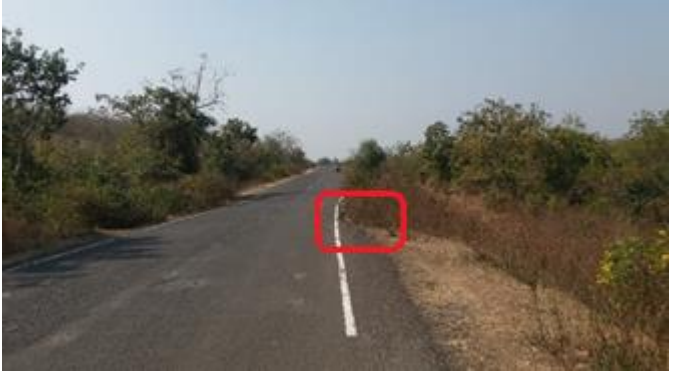
<p>Observation: Sudden contraction of the road but clearly mentioned it with white boarder lines. Reason for Concern: This sudden contraction of the road gives no time to the vehicular to respond to the situation on the road and may lead to a vehicle moving out of control. The white border line attracts the vision of the driver and tells that the width of the road is decreased. Recommendation: Along with Good markings, Warning sign has to place to make the driver known about the situation of the carriageway. Priority: Essential</p>

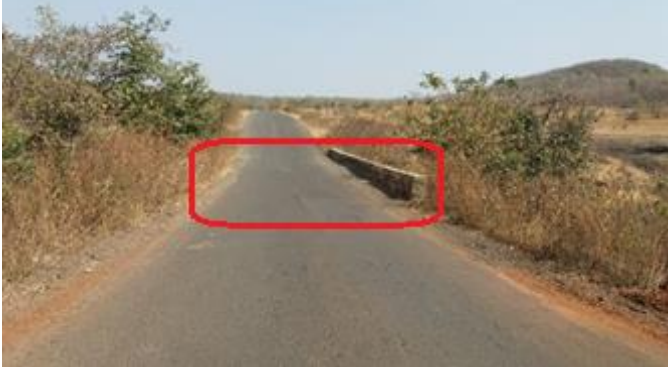
<p>Observation: Culvert walls very near to the carriageway.</p> <p>Reason for Concern: This roadside object is very hazardous to the two - wheelers and they can be hazardous to the window seaters in the buses. The culverts may pose greater damage when vehicles hit them.</p> <p>Recommendation: Warning sign indicating culvert and speed limit signs need to place. With impact absorber, 20% of the potential crash reductions can be reduced.</p> <p>Priority: Essential</p>

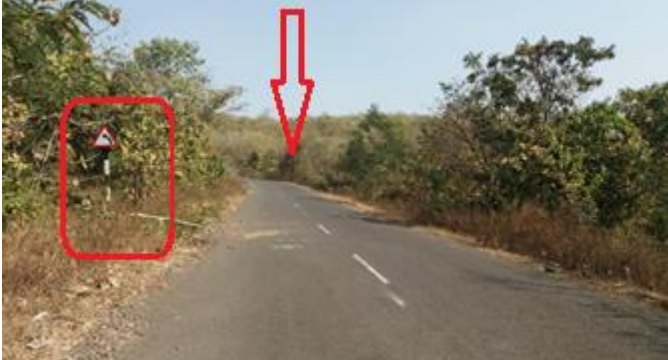
<p>Observation: warning or information sign placed on the wrong side</p> <p>Reason for Concern: warning or Regulatory sign may sometimes be so sited that they have poor conspicuity.</p> <p>Recommendation: As the road is only 3 meters width, left turn directional sign, need to place at the outer side of the curve. Red – Yellow chevrons signs need to place at the turnings.</p> <p>Priority: Essential</p>

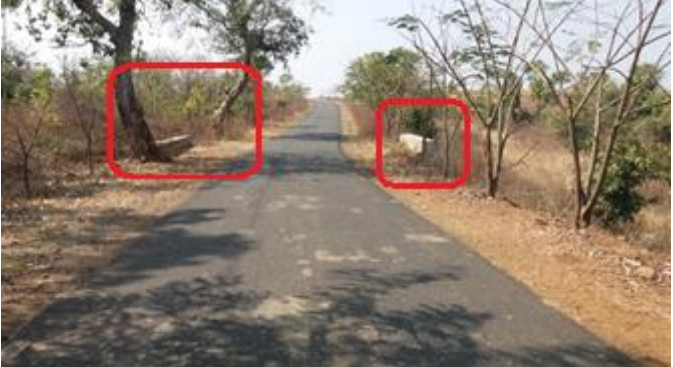
<p>Observation: Maintained a clear distance between the road edge and the culvert wall. Big trees near the road edges.</p> <p>Reason for Concern: Great care should be taken concerning the positioning of roadside features, which may obstruct visibility, lead to crashes or increase crash severity.</p> <p>Recommendation: The hazard (Tree) need to move away to create a larger clear zone</p>

<p>of 1.5 meters width or recovery area. The crash cushions need to install to the culverts and trees. The roadside hazards are to be marked in white color to enhance visibility. Priority: Very Essential</p>

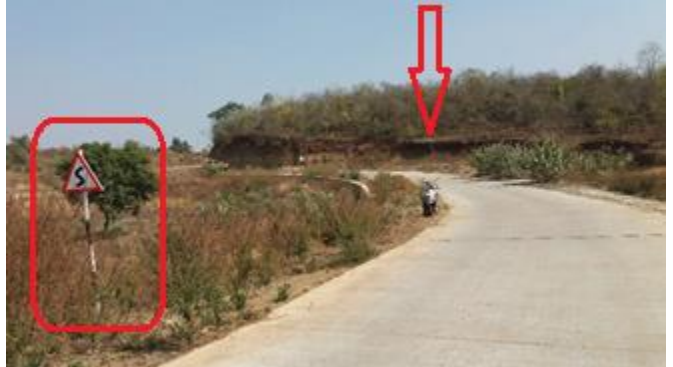
<p>Observation: Sign indicating the curved road but placed very near to the curve. Reason for Concern: As the speed of the vehicles reaching this curve is more than 40 KMPH, they require more reaction time for controlling the vehicle. Recommendation: S-Curve needs to place ahead of 80 - 120 meters of the curve. Red – Yellow chevrons signs need to place at the turning edges. Priority: Essential</p>

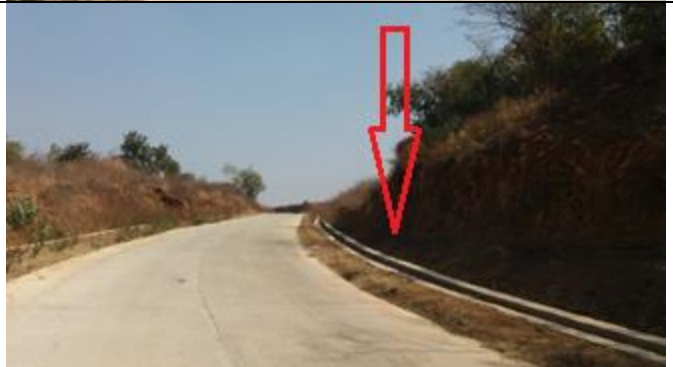
<p>Observation: PMGSY Road constructed with well drainage facility without proper covering the top side. Reason for Concern: Hazardous to the vehicles that run off the road. Unprotected U and V type ditches present a hazard to motorized vehicles particularly motorcyclists. Recommendation: Covering of the drainage system should have done. Priority: Very Essential</p>

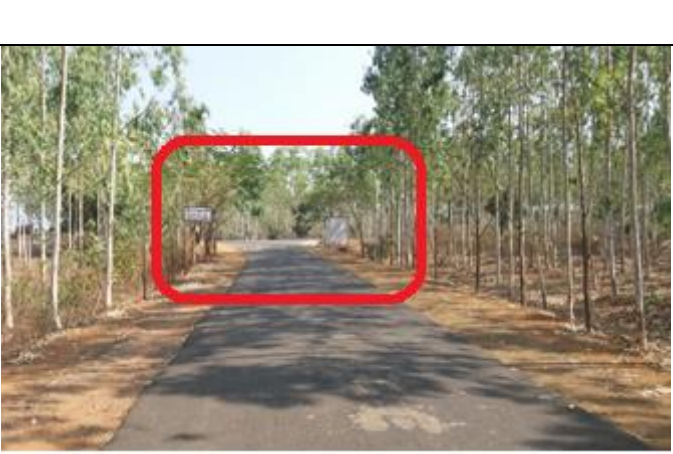
<p>Observation: At T-junction, a minor road connecting the major road. The end of the Minor road clearly shows the end with trees as background. Reason for Concern: The end of the road is clearly known to the drivers by seeing the trees in the background. Recommendation: Rumble strips need to provide to alert the driver before entering the T Junction. Adding trees at secondary roads, which shows that there is intersection ahead and the road is closed. Priority: Essential</p>
