Corroded Post-Tensioned Concrete Beams Fatigue Behavior Under High Cyclic Loading

Abstract: Corrosion of tension wires in bonded post-tensioned concrete beams accelerates fatigue damage accumulation and shortens fatigue lifespan significantly. In this article, the fatigue behavior of post-tensioned concrete beams is studied experimentally under varying strand corrosion levels and high cyclic loading. An accelerated corrosion test is conducted in order to acquire varied corroded beam specimens. First, eight test beams were designed, and one of them was statically tested. Furthermore, the fatigue amplitude was determined using static test results. The remaining seven beams with various corrosion degrees were subjected to constant amplitude high cyclic fatigue loading tests. The test findings reveal that as the corrosion level rises, the failure mechanism shifts from non prestressed steel bar fracture to prestressed steel strand breaking. And under high cyclic loading, fatigue cracks initiate and propagate rapidly around corrosion pits. prestressing wires exhibited fatigue fractures at the minimal cross-sections where corrosion pits had grown. Consequently, a fatigue load test was us

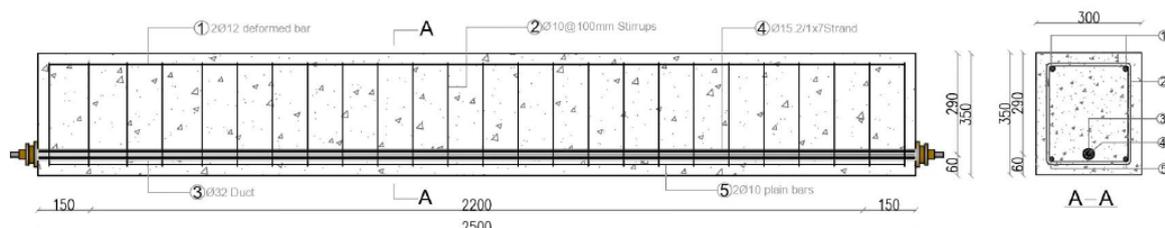
Fig. 1. Beam Details (Unit: mm)

A total of eight post-tensioned concrete beams are designed and constructed. The beams are all $300 \times 350 \times 2500$ mm in size. Two 10 mm simple bars at the bottom, two 12 mm deformed bars at the top, and 10 mm stirrups placed at 100 mm intervals reinforce the beams. The beams are cast with a 32 mm concrete duct and stressed with a 15.2 mm seven-wire strand. C50 types of concrete have been used. The strand's initial prestress is 1395 MPa, which is approximately 0.75 times of its yield strength. Through the channels at the ends of the beams, grout was injected into the duct. Fig. 1 shows the details. Before the beams were built, the strands and reinforcing bars were evaluated for tensile strength. The prestressing strand's average yield strength was 1830 MPa. For the 12 mm deform bars, the average yield strength was 400 MPa, and for the 10 mm plain bars, it was 335 MPa. The concrete mixture contained 416 kg/m³ of Portland cement. The coarse aggregate had a weight ratio of 1.6 to the fine aggregate. The water-cement ratio (w/c) is 0.46.

The beams were simply supported and loaded at two symmetrical four-point loads with a span of 2200 mm. As a point of reference, two beams were left in normal environmental conditions, while the strands of the other six beams were artificially corroded up to mass losses of 10%, 15%, 20%, 25%, 30%, and 35%, respectively. To determine the ultimate load capacity, one uncorroded beam was tested under static loading, in order to estimate the fatigue tests' minimum and maximum loads. One uncorroded and six corroded beams were evaluated under cyclic loading at a constant load range. The degree of corrosion was measured by gravimetric mass loss to simplify engineering applications.

A method of artificially accelerated corrosion testing is used. The corrosion region is 150 mm distant from each side of the mid-span corrosion area. The strand corrosion was electro-chemically accelerated after 28 days of concrete cure to get varied area losses. An epoxy cloth coating was employed to protect stirrups and longitudinal rebars from corroding. The corrosion system was composed of a direct current galvanostat, a strand anode, as well as a stainless steel cathode submerged in a 5% saline solution. A special corrosion tank was created and attached along the beam to prevent strand ends from being buried in the salty solution. Prior to the electrolytic corrosion, the beams were immersed in a saline solution for three days to aid in the corrosion process. A constant current density of 250 A/cm² was applied [25].

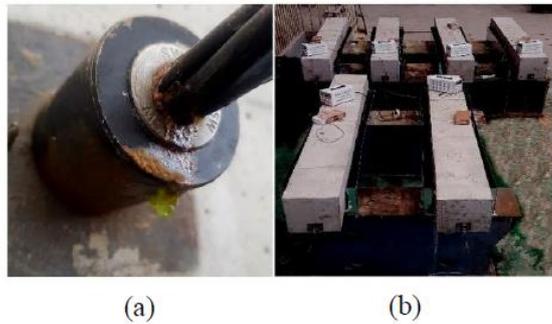
Fig. 2. (a) Corrosive liquid on anchoring zones
(b) arrangement of accelerated corrosion system

For the different corrosion levels of the strands in the beams, different durations of impressed current were used based on Faraday's law. The schematic layout of the accelerated corrosion system is shown in Fig. 2. The duration of the corrosion process was determined by Faraday's law, in order to achieve the desired suitably corrected with a scale factor $\alpha \geq 1$, to consider the corrosion process's time lag, due to the protection provided by the concrete cover [26]. Faraday's law can be expressed in the following way.

The flow of red rust and saline solution can be facilitated by the gaps between the twisted wires. Liquid migration has a negative impact on the structural lifespan and might cause corrosion to spread throughout the strand, as seen in Fig. 2. Corrosion loss in the strands of each beam was measured using a destructive technique. After the loading test, the concrete covering was removed, the strands were taken out, and the grout from their surfaces was wiped down. Corroded strands were cleansed with a 12 percent hydrochloric acid solution and neutralized with alkali. Corrosion is observed as the strand is separated into wires. A contour gauge was used after this to determine the remaining cross-sectional area of each wire.

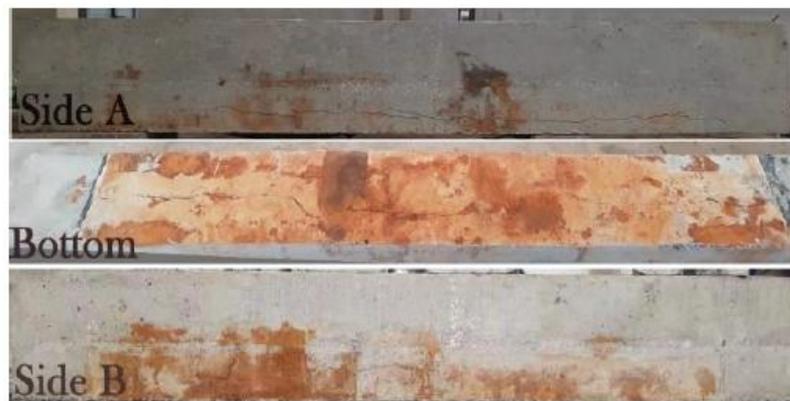
Fig. 3. Corrosion-induced cracks in beam PCB4

Following the accelerated corrosion, the corrosion-induced cracking of PC beams was studied. On the side and bottom surfaces of the corroded beams, longitudinal cracks were detected. Cracks for the slightly corroded beam PCB4 is shown in Fig. 3. Along the beams, the cracks are almost interconnected. The corrosion-induced cracks varied in width across the beam. Near the cracks, some rust spots appear.

Beam CB4 has a similar crack morphology to other corroded beams. An electric crack detector with high precision was used to measure the width of corrosion-induced cracks every around 7cm length. The average crack widths on the sides and bottom from all corroded beams are depicted in Fig 4. Increasing strand corrosion levels caused these cracks to widen. The bottom cracks were wider than those on the side surfaces due to the thin concrete covering. In beams PCB3 and PCB4, the crack width was consistent across the longitudinal axis.

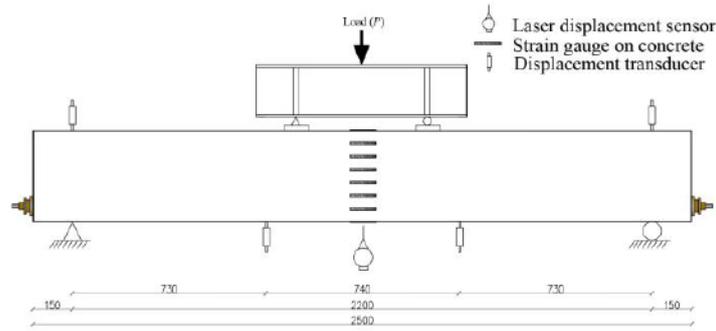
Fig. 5. Loading test set-up (Unit: mm)

The fatigue tests were conducted on the MTS electro-hydraulic servo-controlled fatigue-testing equipment, which includes a computerized system with seven test beams. Figs. 5 and 6 show the details of the fatigue test setup. To precisely determine the fatigue test load, the reference beam PCB1, which was free of corrosion, was monotonically tested to failure to determine the first cracking load P_{cr} and the ultimate load P_u . The remaining seven beams were subjected to cyclic loading with lower and maximum limits of 0.1 P_u and 0.40 P_u . The static load was applied before the cyclic loading began, and the load was steadily raised until it reached to P_{max} , it was then reduced to zero. Crack load, initial deflection, strain, and crack width were all taken into account and recorded. Then, at a frequency of 5 Hz, the load was applied in a cyclic pattern with a constant load range. After a certain number of cycles, the cyclic loading was stopped, 10,000, 20,000, 50,000, 70,000, 100,000, 150,000, 200,000, 300,000, 500,000, and 1 million respectively. Then fatigue loading test paused when the repeated cycles reached every step, and to assess the status of the beam a static cycle was performed between zero and P_{max} . Each time the fatigue testing was paused for static loading, data was taken from all of the equipment. During static loading, the crack width was also measured.

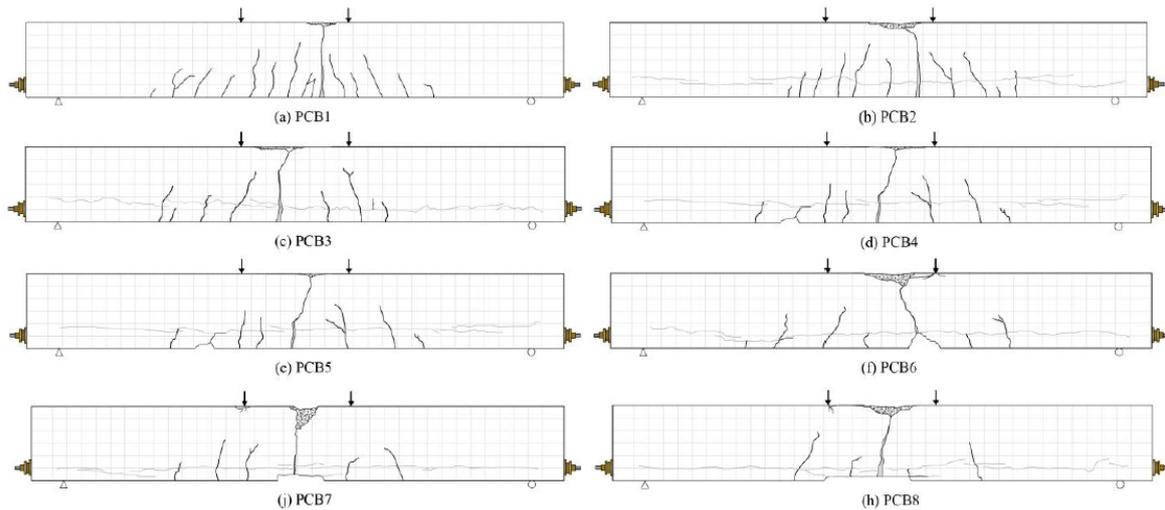
Fig. 7. Failure modes of beams in fatigue tests

Therefore, fatigue failures occurred due to fatigue fracturing of rebars in uncorroded beams. As a result, for PCB2 approximately 1058010 cycles, the rebar fracturing occurred, and the beam promptly collapsed in a brittle state. This corresponds to previous findings [27]. Both rebars failed at the main crack, and there were no obvious signs of plastic deformation at the fracture surface. Fatigue cracks occurred and propagated rapidly around corrosion pits in corroded prestressing wires under cyclic loading. Under the same fatigue loading, corroded prestressing wires fractured before uncorroded tension rebars. Despite the fact that the wires had a lower nominal stress range. The remaining prestressing wires and rebars were fatigue fracturing in order till the beams collapsed brittlely. At the minimal cross-section, the first prestressing wire fractured, where there have been corrosion pits. Fig.7 illustrates the failed beams. Table 2 demonstrates the test beams' fatigue lifespan. As can be observed, the fatigue life drops dramatically as the corrosion level rises. The fatigue life span of the beams PCB3–PCB6 are 95.84%, 87.15%, 75.52, and 60.77% of that of the reference beam PCB2, respectively. The fatigue cycles at failure for the severely corroded beams PCB7 and PCB8 were 411000 and 137000, respectively, which are only 38.84% and 12.94% of the uncorroded beam. This is due to the fact that corrosion decreases the stand wire's net section area while raising the nominal stress amplitude. Fatigue failure is hastened by corrosion pit-induced stress concentration and covers spalling. Fracture analysis is one of the most extensively utilized approaches for analyzing the causes of fatigue crack development and propagation. The steel bar's fracture morphology is divided into two regions. A slow-expanding zone and steady fatigue crack growth region.

From the reinforcing surface to the radial direction, the fatigue crack takes on an arc form. Under fatigue load, the fracture of corroded strand wire is detected in the greatest corrosion pit position. As corrosion levels rise, the length of the stable fatigue crack development zone reduces. Corrosion accelerates the fatigue damage process by causing the Strand wire to reach the fast-expanding stage earlier.

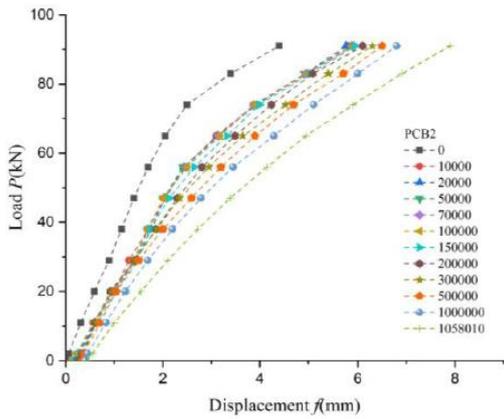
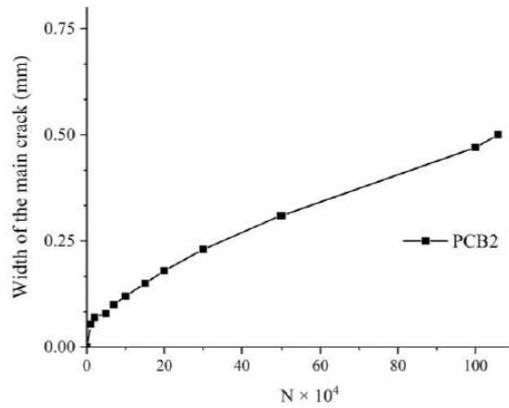
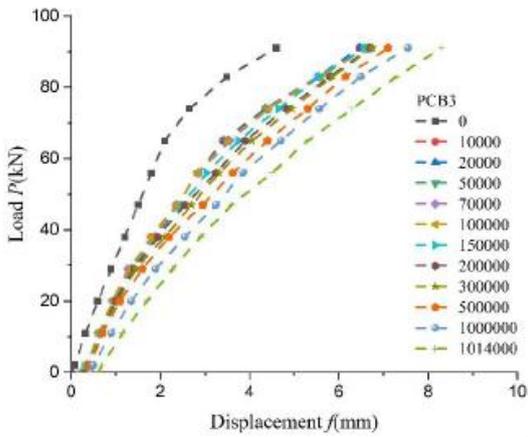
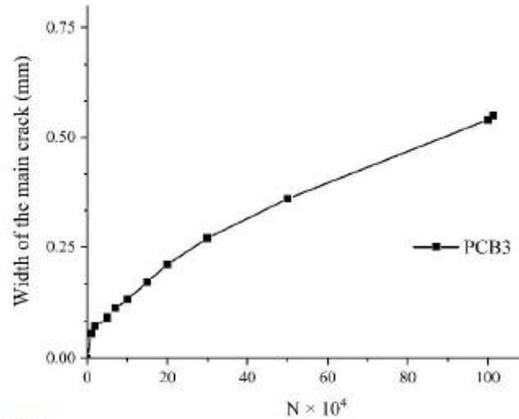
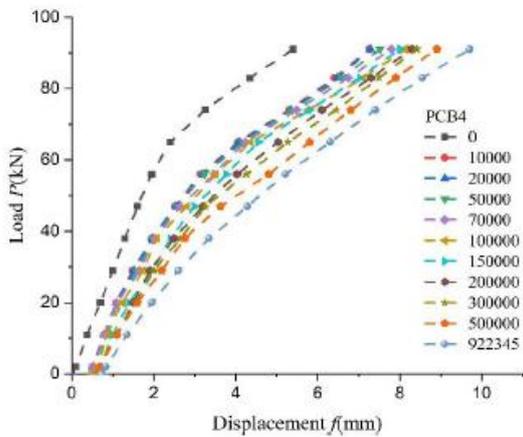
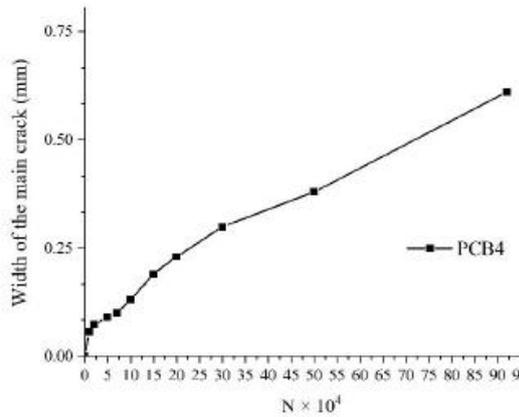
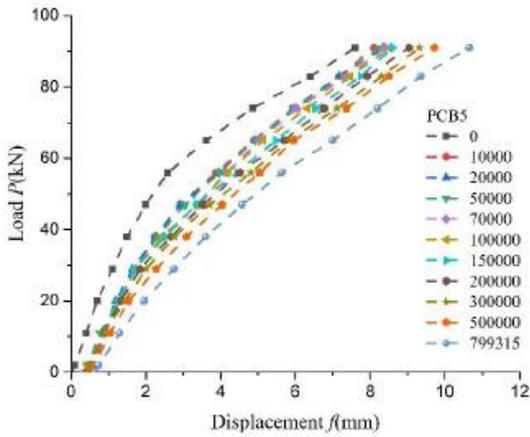
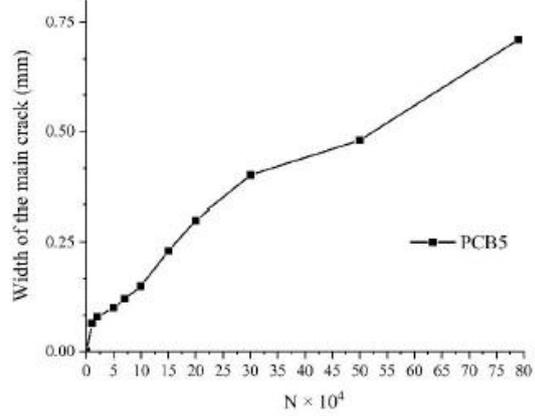
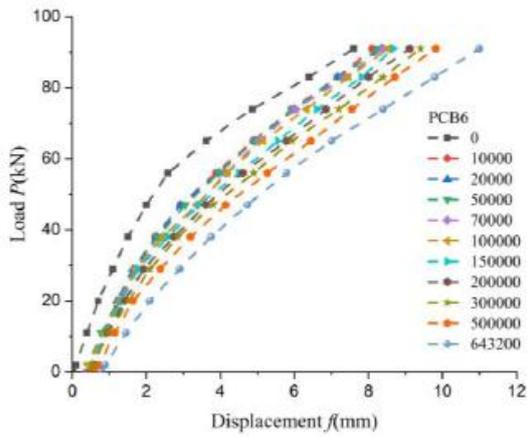
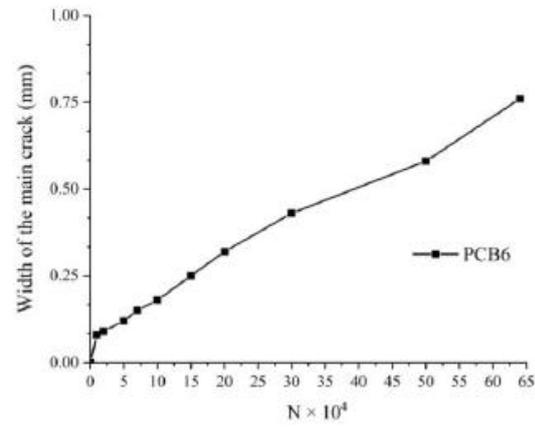
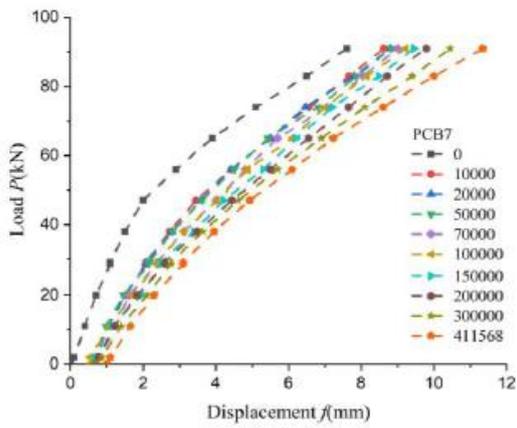
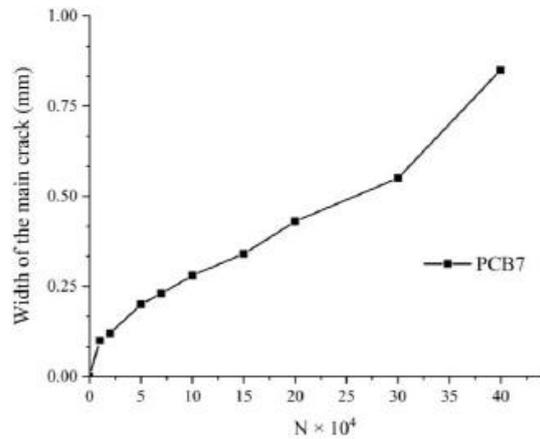
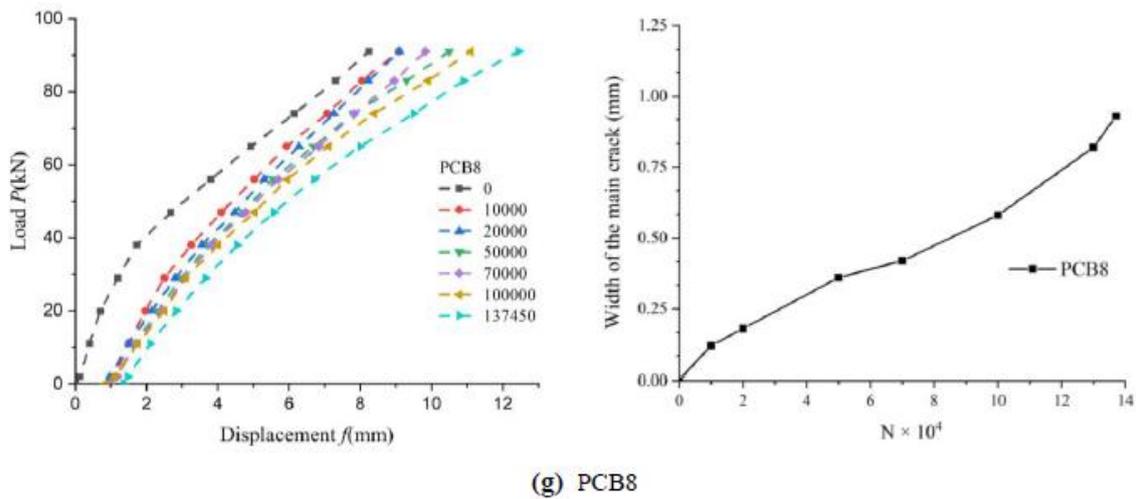
Fig. 8. Load midspan deflection curve and Crack Width (Unit: mm)

To find out how corrosion and fatigue impact the mechanical behavior of PC beams. Once the fatigue cycles have reached the required levels, the mid-span deflection is measured, as shown in Fig. 8. Strand wire's strength and cross-section are reduced by corrosion, particularly in severely cracked beams PCB7 and PCB8, and results in a reduction in the bond between strand wire and concrete. Fatigue reduces the flexural rigidity of PC beams, as can be shown. The flexural stiffness of PC beams degrades as a result of fatigue. Furthermore, after the same number of fatigue cycles as the virgin beam, the measured deflection increases. As the corrosion-induced fracture width rises, the distance between the deflection curves of various beams under different loads rises revealing that for the same cycle, structural stiffness is more susceptible to the width of corrosion cracking. The initial maximum deflections of PCB3–PCB8 beams increase by 10.23%, 22.1%, 42.03%, 53.01%, 69.51%

and 85.67%, respectively, when compared to the un-corroded beam. And as it seems under cyclic loading, mid-span deflection and strain gradually increased. The corroded beams exhibited more deflection, wider cracks, and greater strain under cyclic loading than the uncorroded beams.

Fatigue test beam load-displacement curves depict in Fig.8. As the number of fatigue cycles increases, the load-displacement curve shifted in the direction of greater displacement. In the early and late stages of fatigue, the load-displacement curves were unevenly distributed, while at the medium stage of fatigue were denser. The slope of the load-displacement curve decreased as the number of cycles increased. This implies that the test beam was losing rigidity and softening. Progression of the major crack and the load-displacement curve, as shown in Fig.8 and comes with a three "S" form law. During the whole phase of PC beam fatigue process, the vertical cracks with a limited number and length occurred in the mid-pure span's bending region. The crack size was approximately 0.07 ~ 0.95 mm. Vertical cracks in the pure bending portion became larger and longer with time, and the number of cracks increased during the middle stage of fatigue. And around the loading points, the bending and shearing section developed oblique cracks. As the cyclic load was applied, the cracks opened and closed again, and the fractures on both sides of the beam were connected at the bottom. At this moment, the cracks' width, length, and number were all increasing. The major crack was 0.25 to 0.4 mm wide. Dynamic creep accumulated damage to the steel bar and prestressing strand during the fatigue process. The damage to the steel bar and prestressing strand accumulated throughout the fatigue process as a result of dynamic creep. When the bottom steel bar for beams PCB2 and PCB3 experiences tensile stress, and Strand wire for the beam PCB4 to PCB8 reached the critical point of tension, obvious dendritic oblique cracks appeared in the final stage of fatigue, for uncorroded beam PCB2 and less corroded beam PCB3, the steel bar fractured abruptly, resulting in significant increases in displacement and main crack width. The test beam had reached fatigue failure at this point. although the beam could still bear fatigue loads, but the external loads applied to the beam have greatly reduced. However, for beams with corroded prestressed strands, PCB4 to PCB8 wire fractured accrued prior to steel bar fracture during the middle and end stages of fatigue. The fatigue damage to the bottom tensile reinforcement and strand wire was steadily increasing, the fatigue failure of the PC beam was caused by the rapid fracture of the steel bar and prestressed wire.

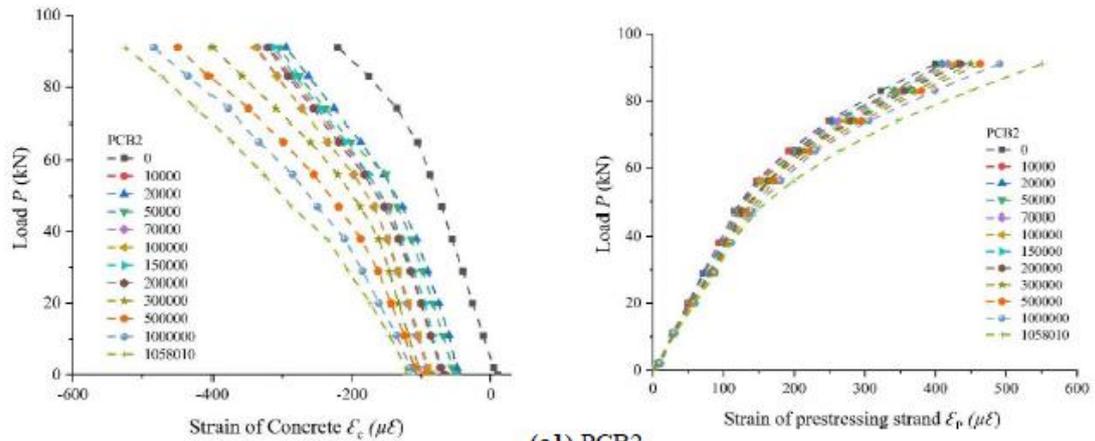
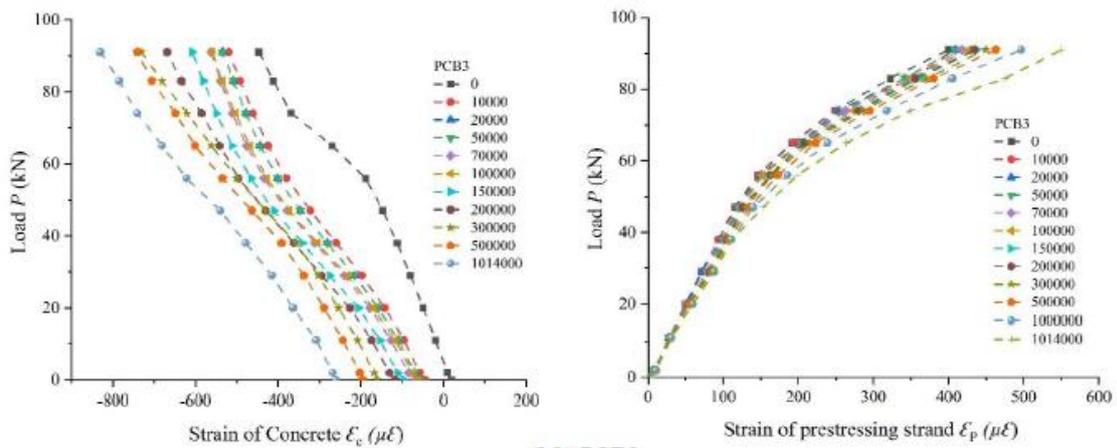
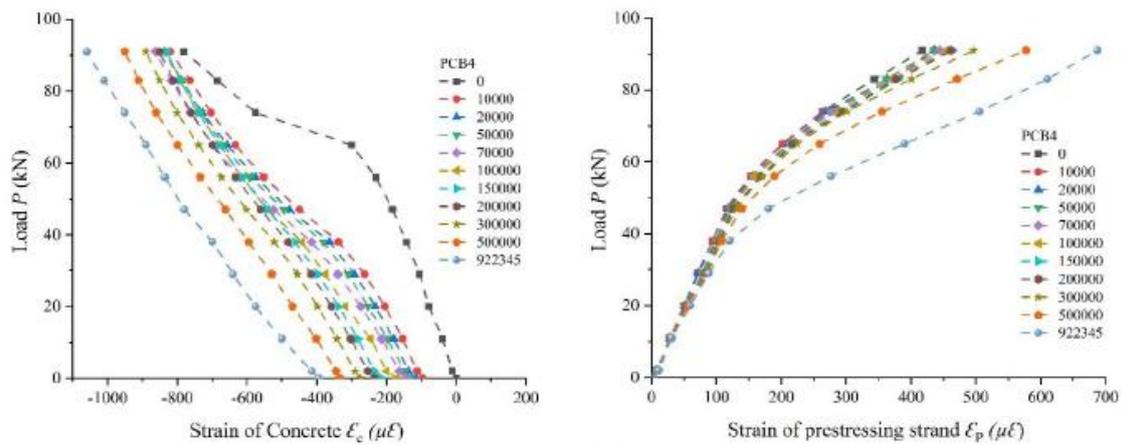
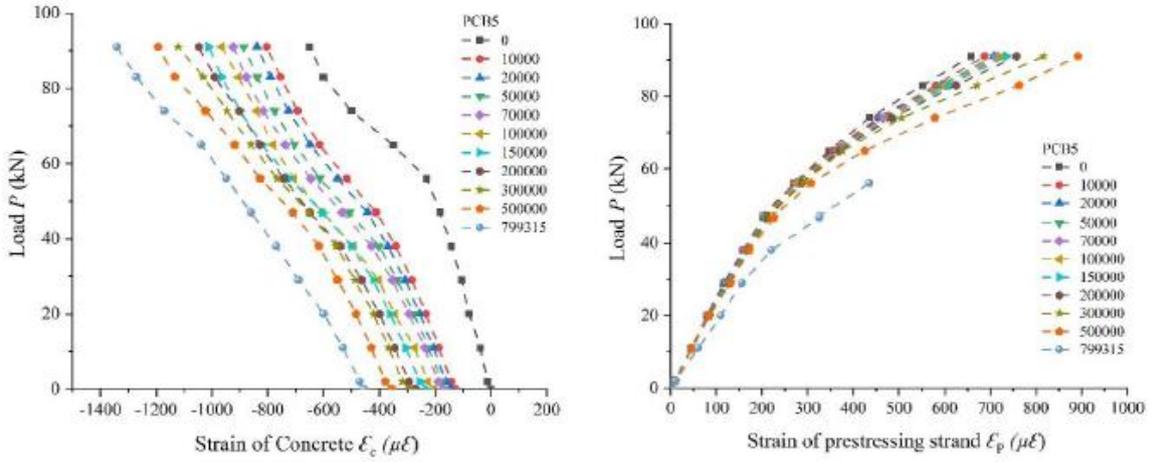
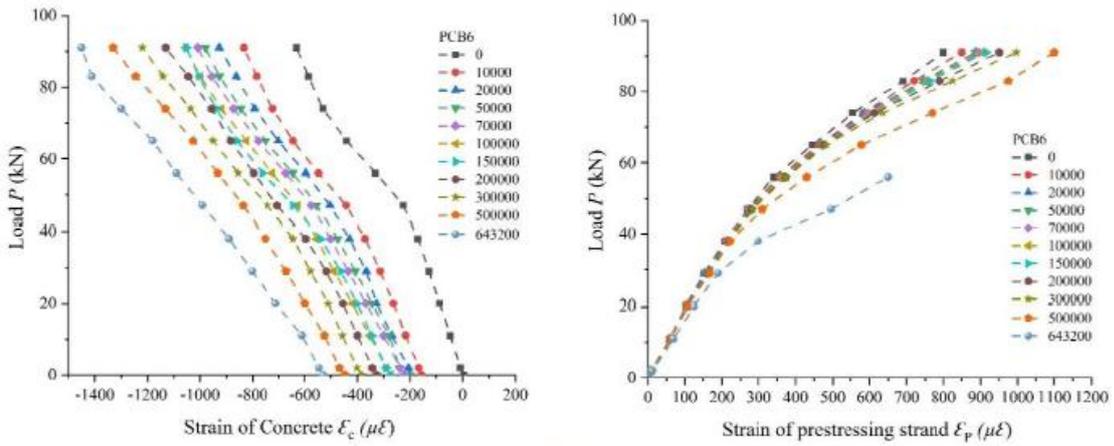
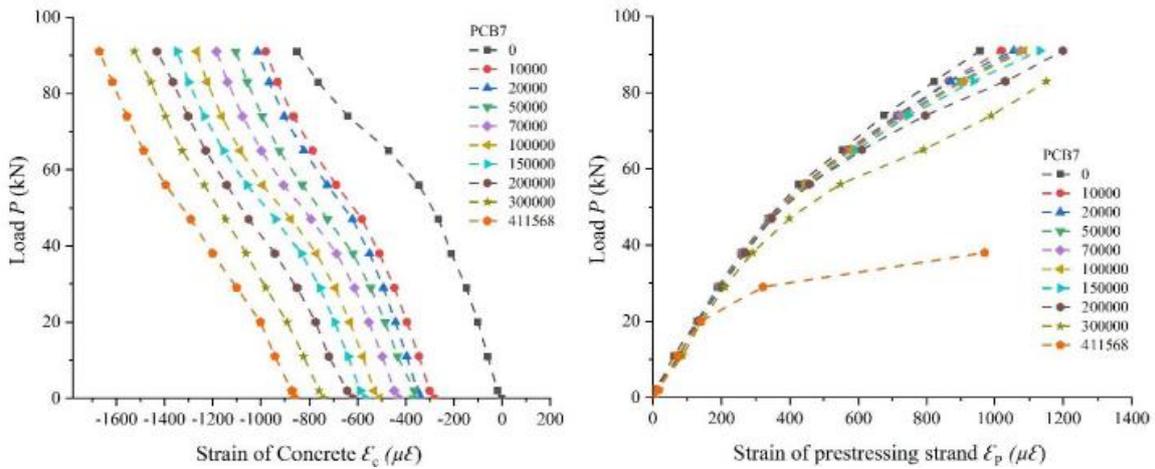
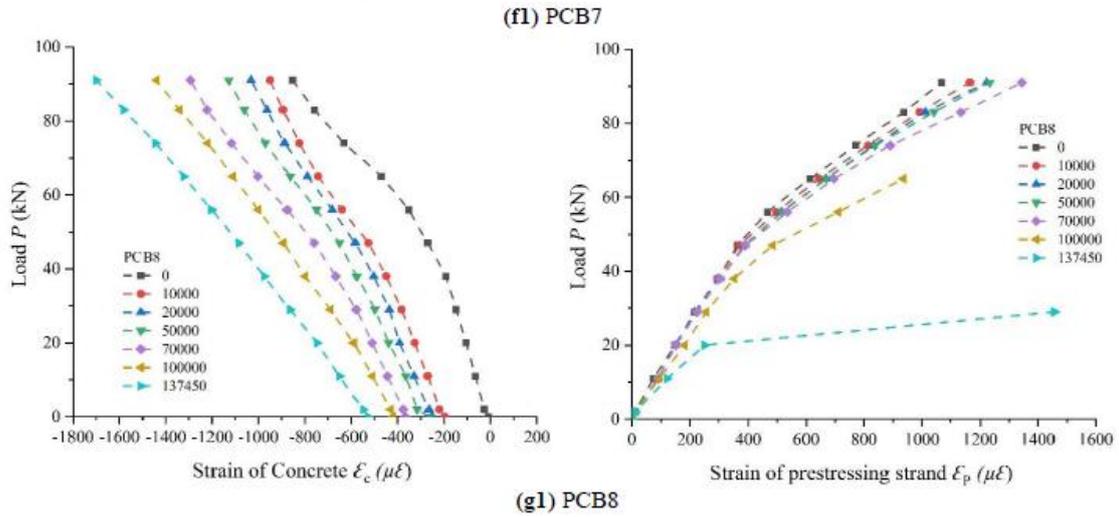
Fig. 9. Strain development of concrete, and prestressing strand under constant fatigue loading

The load-strain curves of concrete in the compression zone, the bottom steel bar, and the prestressing strand under constant-amplitude fatigue loading are depicted in Fig 9 and 10. Tension is represented by positive strains, and compression is represented by negative strains. The effects of efficient prestress and test beam weight is taken into consideration when calculating the initial strain of concrete prior to fatigue loading. Through the test, strain is measured during the fatigue process. Concrete's strain-load curve can be determined by superimposing the two strains above. Due to construction conditions, certain steel bar strain gauges and prestressing strands were damaged. As a result, the pure bending region was picked for as much as feasible of the undamaged strain data. A zero value was assigned to each load-strain curve. Results of the tests indicated that concrete strains increased towards the direction of increased compressive strain. Furthermore, the slope of the steel bar and prestressing strand load-strain curves were steadily decreasing, and both steel bar and prestressing strand had plastic characteristics. Furthermore, the slope of the steel bar and prestressing strand load-strain curves were steadily decreasing, and both steel bar and prestressing strand displayed plastic characteristics. some of The strain gauges were damaged in the final stage of fatigue, preventing parts of the strain data from obtained.
