Investigation of Architectural of Aksaray Grand Mosque and Structural Deterioration Factors

Ahmet Gökdemir "Investigation of Architectural of Aksaray Grand Mosque and Structural Deterioration Factors." *IOSR Journal of Engineering (IOSRJEN)*, vol. 07, no. 12, 2017, pp. 85-90.

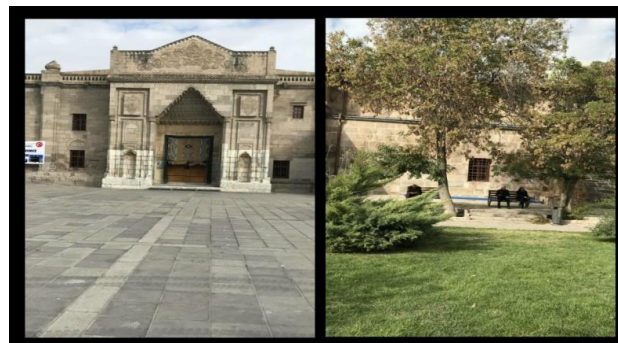
Fig 3.1 Aksaray Grand Mosque (Front and Side View) [15].

3.2. Construction Material: Properly cut stone and rubble stone combined with horosan mortar in the walls, feet, arches and vaults were used as building material in the construction of the mosque. The domes on the front of the altar and the muezzin are covered with bricks. The facades are built of rubble stone. Wood is used in doors, windows, upholstery and roof coverings. In the eastern, western and northern frontal windows, a snap-on iron rail, a north-facing left-hand iron rail and a north rail front rail are used. Make the current top cover is copper. In addition to these, tiles are used in the interior [12].

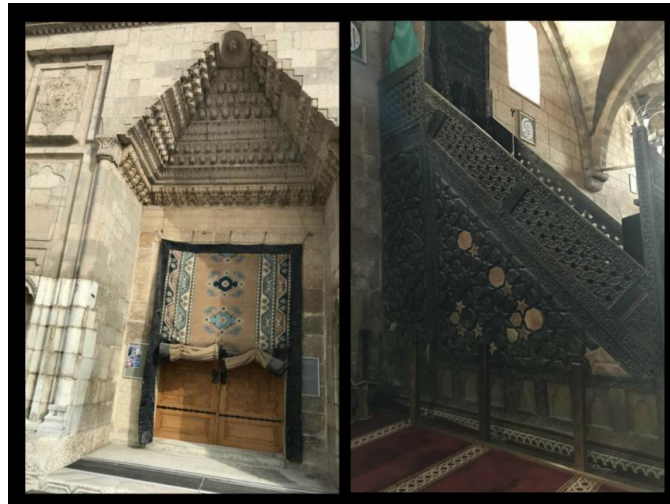
The most unique material of the mosque is striking the pulpit. Wooden pulpit made with kundakari technique, decorated with mother of pearl inlay and embossed [10].

Fig 3.3 Crown Door and Wood Minbar [15].

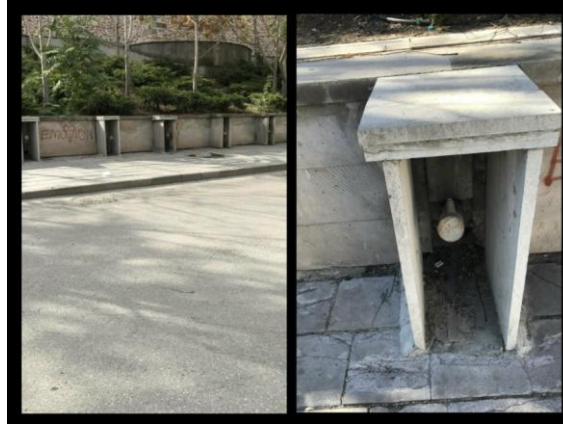
3.3 Construction and Construction Technique: The mosque, which was built as a stone structure, was supported by sherds. Five of them are located in the west direction, three in the north direction and three in the south direction [10]. They are the greatest shareholders in the eastern direction carrying the actual burden. The reason for this is that a sloping land composed of an artificial fill was built [13].

Fig 3.4 Supporting Transporter [15].

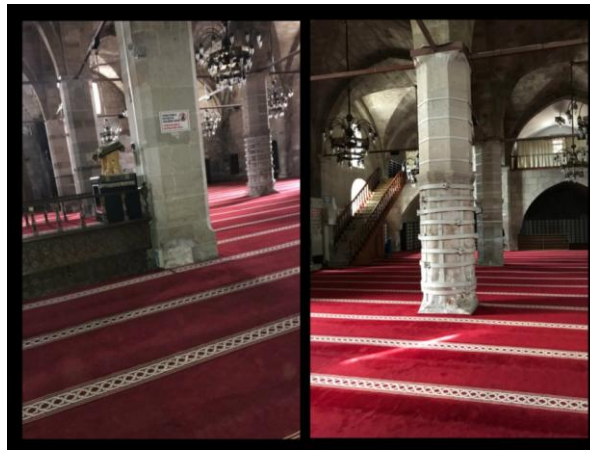
The mosque mihrab consists of five sections vertically [13]. Twelve octagonal formations separate the sections of the pointed arches connected to each other and the walls. The cross is covered with vault over the sections. There are only two small domes in front of the mihrab and above the muezzin. It is stated that there are four windows in these domes, but they were closed during a repair. [14] There is a pendant dome and a small dome [13]. On the north side is a two-storey section with five arcs. In the present case, the lower part is used as the last community place and the upper part is used as the women's department. The mosque is covered with a barrel vault. This division can be exited from outside as well. The middle part of the mahfel is adorned with very elegant isotactics. The most recent arched section on the mahfel is located on the east side with a door space and stone steps [14]. It is entered from a monumental crown door protruding long and forward from the body walls in the west. [13] It can also be harvested from the north with a door and from the coffin. A door that opens to the north outside these doors, but to the left of the northern surface that was closed later, is present inside and is built with stone from the outside [14]. Because the mosque was built on a mound, it cracks and separates from the walls, so the vault of the glass is covered with soil. The leaks cause the slipping of the walls as the soil continues to be thrown away. In order to prevent these shifts, the southern part of the camel was built with stakes [14]. The original state of the mosque mihrab is made of plaster, and today the wooden mihrab stands out. Mimber came with the original state of the day. Made of ebony wood and decorated with floral motifs is a masterpiece of woodworking pulpit. [14] The first state of the minaret of the mosque was built in 1706 and the present state was built in 1925 and the mosque was placed separately [13]. In the general layout of the mosque, there is a rectangular planned lecture hall and a rectangular space which is used as a book selling place [10].

Fig 3.5 Situation of Interior and Carrier Systems [15].

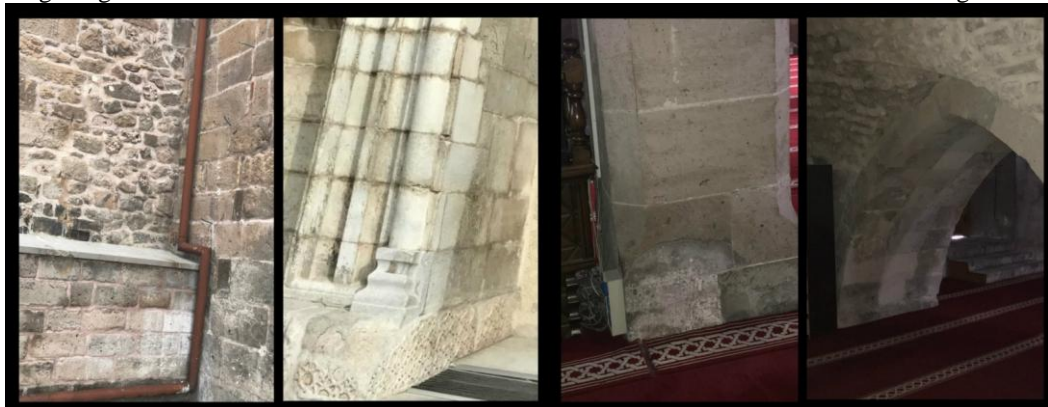
Fig 4.1. Outdoor Miscellaneous Distortions, Interior Various Distortions [15].

As a result of the examinations made, it is seen that the isotacticities of the door portal have lost originality, the mosque has lost its original garden and threshold levels, the interior of the coffin has lost its vault stones and its tie, it has been observed that in many façades the joints are emptied at the joints to affect the bearing characteristics of the stones, the stones lose their qualities on some façades, there are intermittent blackouts on the interior surfaces, the gypsum mihrab is removed and the wooden alcoves are changed in different shapes.

The consequences of these examinations should be incorporated into a permanent and permanent restoration program, in accordance with the architecture, building materials and construction technique. The Aksaray region has attracted attention from domestic tourists as well as being a stop for foreign tourists for many years. With this restoration, our culture will be preserved and it will provide economic return in terms of
