## The Architectural Investigation of Akseki Butonned Houses and Suggestions for Their Restoration

Ahmet GÖKDEMİR<sup>1</sup> Onur ÖZEN<sup>2</sup>

Ahmet GÖKDEMİR. " The Architectural Investigation of Akseki Butonned Houses and Suggestions for Their Restoration." IOSR Journal of Engineering (IOSRJEN), vol. 08, no. 11, 2018, pp. 23-31.

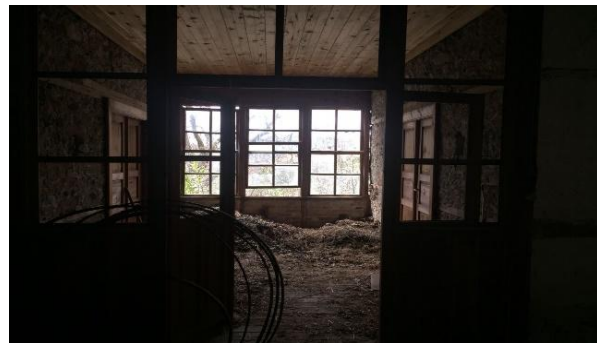
**Figure 8:** Butonned House floor sample [13]

**Floor:** The building floors are in the form of wooden rafters and underlay cladding boards. They are in good condition and cleaning is sufficient without any damage. (see Figure 13)

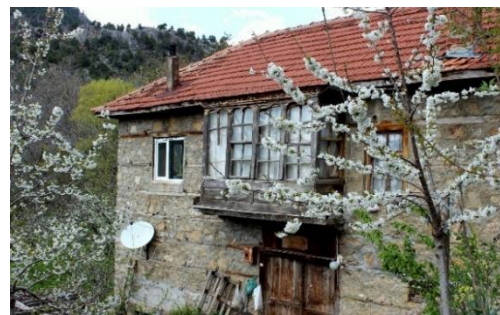
**Figure 10:** Butonned House cumba sample [13]

**Cumba and Pavilion:** The cumba and pavilions on the two sides of the building should be removed because they are seriously damaged. It must be re-manufactured according to the same wood material and assembly should be performed. (see Figure 14)
