Fatigue life Analysis of a Thin Cracked Aluminum Alloy Panel Repaired with a CFRP Patch

Abstract: The investigation aims to predict the fatigue life of thin cracked aluminum alloy skin repaired with an adhesively bonded composite patch. In the first part of study, the number of fatigue cycles required to initiate a crack on an existing pre-cracked bare specimen were experimentally obtained for different crack lengths. Further, its effect on the stress intensity factor was studied to find out the fatigue life of the bare specimen. In the second part, the effectiveness of the cracked specimen repaired by an asymmetrically bonded CFRP patch was investigated through experimentation. The skin of the centre-cracked specimen was made of 1 mm thick 6061-T6 aluminum alloy. The pre-crack of different crack lengths were cut using wire-EDM. The pre-existing center lengths were chosen to be: (i) 10 mm (ii) 15 mm (iii) 20 mm (iv) 25 mm and (v) 30 mm. The skin with a center crack of 25 mm was chosen for the further study on the specimen repaired by a unidirectional CFRP patch bonded through epoxy resin. Different configurations of CFRP plies with change in stiffness ratio and length of plies wer

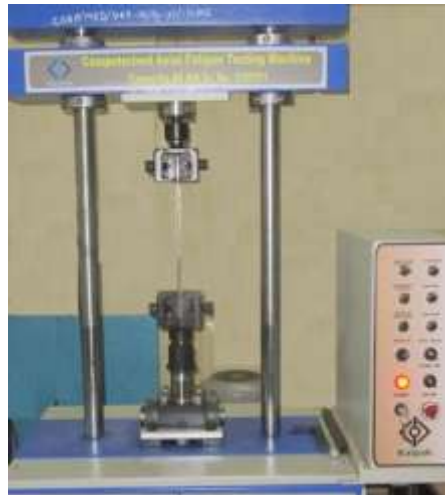
Fig. 2 Photograph of the experimental set-up for uni-axial fatigue testing.

The experiments were carried out on the bare specimens as well as the specimens of skin repaired with carbon fibre-epoxy patches on a computerized axial tension-tension fatigue test machine (Figure 2) by applying fatigue load at the frequency of 10 Hz. The maximum fatigue stress σ_{max} was applied in the range of 25% to 65% of the yield stress (277 MPa) of the aluminum alloy skin. The minimum applied stress σ_{min} was set at 10% of the corresponding σ_{max} . The tests were conducted to explore the relation between stress and the number of cycles required to fail the specimen. (S-N plot) for the bare specimens as well as the specimens repaired with different patch configurations.

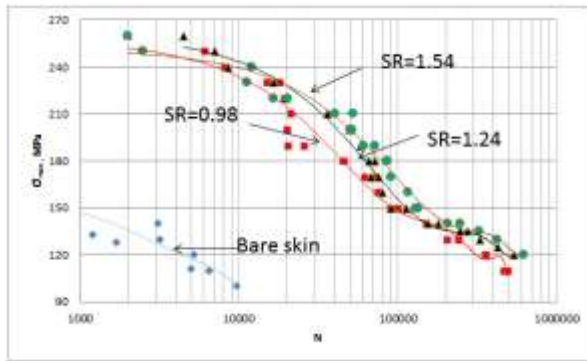
Fig. 6 σ_{\max} vs. Initiation life, N_i

Figure 6 and Figure 7 shows the comparison between number of cycles required to initiate the crack N_i and number of cycles required for complete failure of specimen into two parts N_f for various patch configurations.

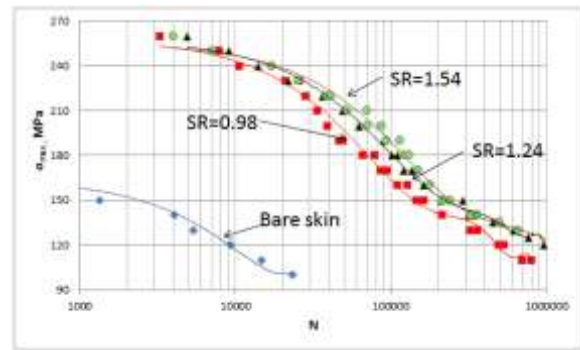
Fig. 7 σ_{\max} vs. Failure life, N_f
