Assessment Of River Bank Erosion Potential In Brahmaputra River In Lower Assam Region Using Modified Rosgen's Bank Erosion Hazard Index Method.

Abstract: The Brahmaputra is one of the major and mightiest rivers of India. It passes about 700 km through the middle of the state Assam and finally enters at Bay of Bengal (India). The river Brahmaputra is very much potential in producing the seasonal flood and river bank erosion in its entire course in Assam. Every year the river migrates laterally here and there by cutting its both alluvial banks and thus huge amount of sediments are produced by destroying acres of fertile land causing tremendous loss of the poor state. It is observed that the rate of erosion is very high in certain locations, the channels are changed completely within a short interval of time with frequent change of depth of channels. After observing the entire course of river in lower Assam region, it has come to notice that the river is eroding its both banks in many locations, but the extent of erosion is not same in all locations and hence it has been attempted to apply the modified Rosgen's method to identify the nature and erosion vulnerability of the locations

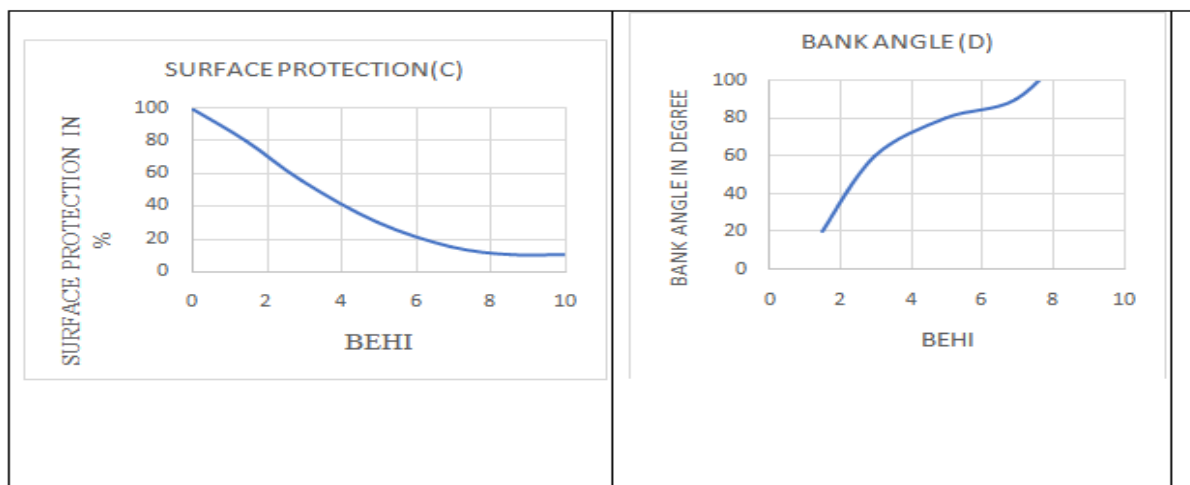
FIG : 1(Stream bank erodibility of variables as per Rosgen’s modified method)

From table 1, it is clear that the predictors of erodibility were converted to a risk rating of 1-10 and these risk rating from 1 to 10 indicate corresponding risk rating category of risk as very low, low, Moderate, high, very high and extreme potential erodibility. Using the table number1, graphs of all key stream bank characteristics are developed to assign the value for risk rating for any observed field value of risk parameters. These graphs are shown in fig 1

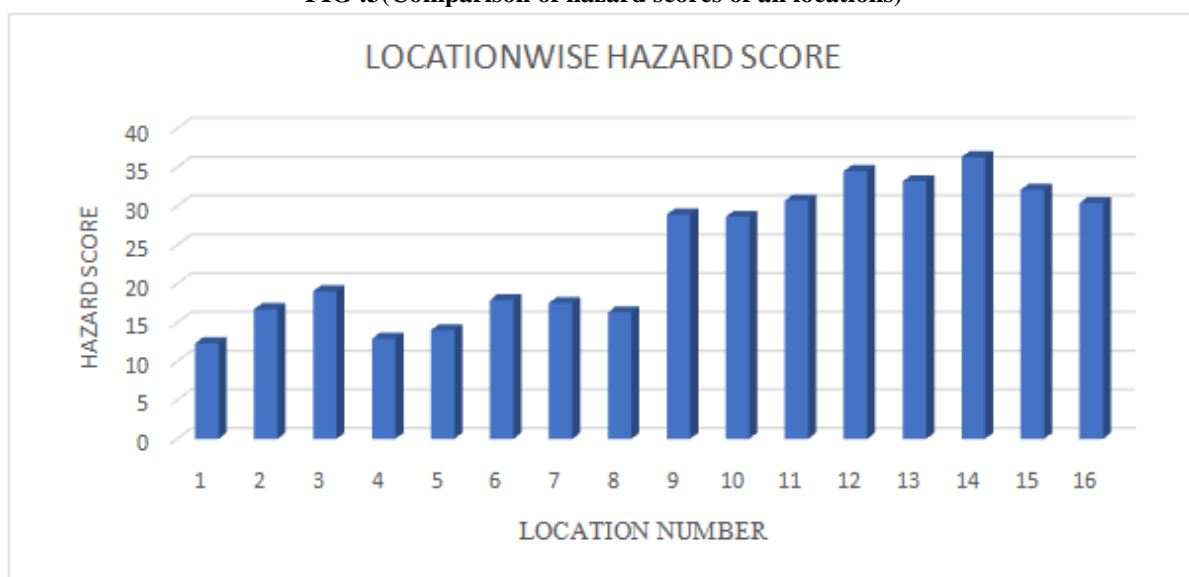
FIG :3(Comparison of hazard scores of all locations)

Location	Score(A)	Score(B)	Score(C)	Score (D)	Total	Category of risk
1	2.5	3.6	3.3	2.9	12.3	Low
2	5.0	5.0	4.2	2.5	16.7	Moderate
3	6.2	5.2	5.0	2.6	19.0	Moderate
4	5.0	2.8	3.3	1.8	12.9	Low
5	3.7	4.4	3.7	2.2	14.0	Low
6	6.2	4.1	5.0	2.6	17.9	Moderate
7	3.7	6.2	5.0	2.6	17.5	Moderate
8	3.7	3.5	6.1	3.0	16.3	Moderate
9	6.2	7.5	8.2	7.0	28.9	High
10	4.9	7.5	8.2	8.0	28.6	High
11	7.6	7.2	8.4	7.5	30.7	High
12	7.7	8.8	10.0	8.0	34.5	Very High
13	10.0	7.5	8.2	7.5	33.2	Very High
14	10.0	8.8	10.0	7.5	36.3	Extreme
15	7.7	8.8	8.2	7.4	32.1	Very high
16	7.7	7.0	8.2	7.5	30.4	High
