Analysis of The Effect of Thunder And Lightning Strike on Television Signal Transmission (A Case Study of Nta Enugu.)

Abstract: The lightning strike and thunder and its effect on television signal transmission in Nigerian Television, NTA Enugu Nigeria was analyzed. From the analyses, it was observed that lightning and thunder strike affects television transmissions. This occurs at the beginning and end of the raining seasons of every year. The result showed that the lightning strike and thunder effect causes image fading lost of signal, breaking of images and sometimes causes the station to be out of broadcast. National Communication Commission, NCC should ensure that all television stations in Nigeria be digitalized and powerful/modern lightning arrester and surge protection device be installed to avert the effects of lightning strike and thunder on their stations to keep transmitter "**ON**" during transmission.

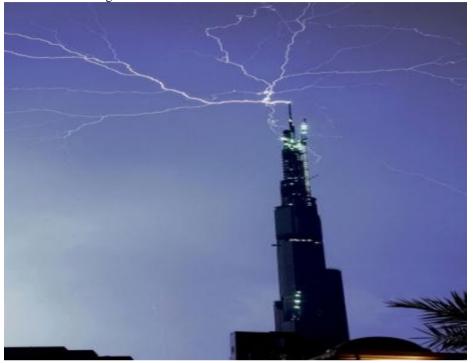
Lightning effect on Transmitter Damaging power surges or transient occurs when lightning strikes transmitter, metallic plant equipments. Lightning damage to transmitter depends on the access route of itsstrike. A direct hit generally destroys a transmitter while a nearby strike can induce damaging current in piping or

wiring. On the process, piping will usually damage the sensor module and may damage the electronic components of the transmitter [Technical data sheet, 2002].
